All Woody Streambank Stabilization

Restoration on HOA Budget

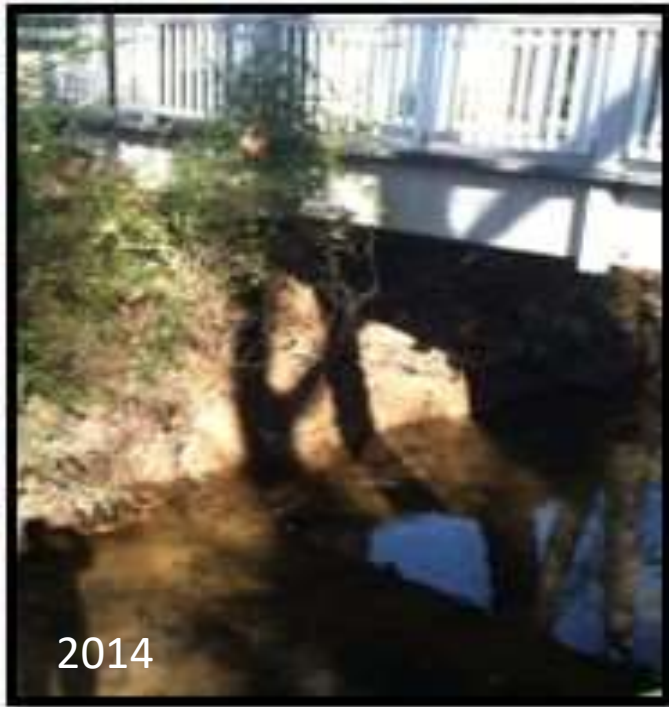
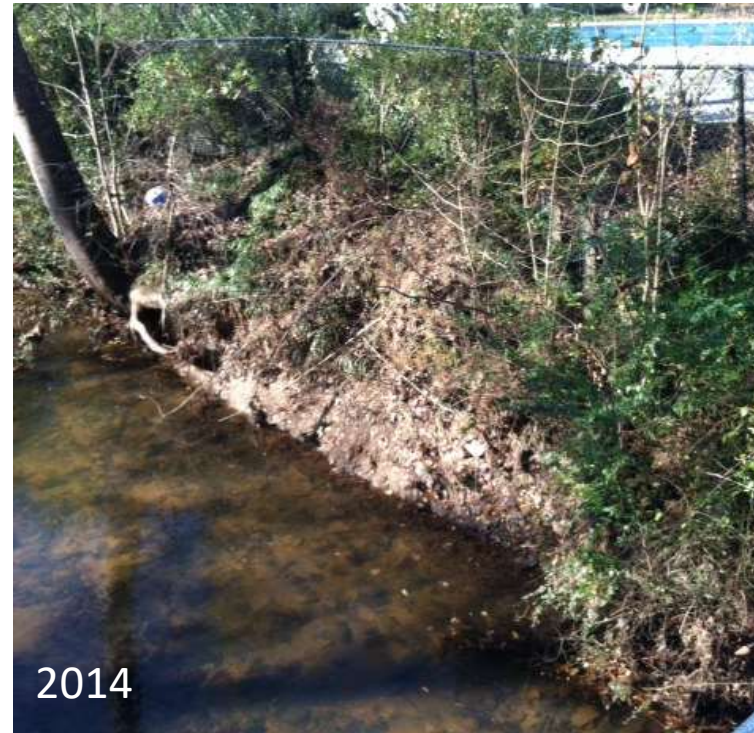
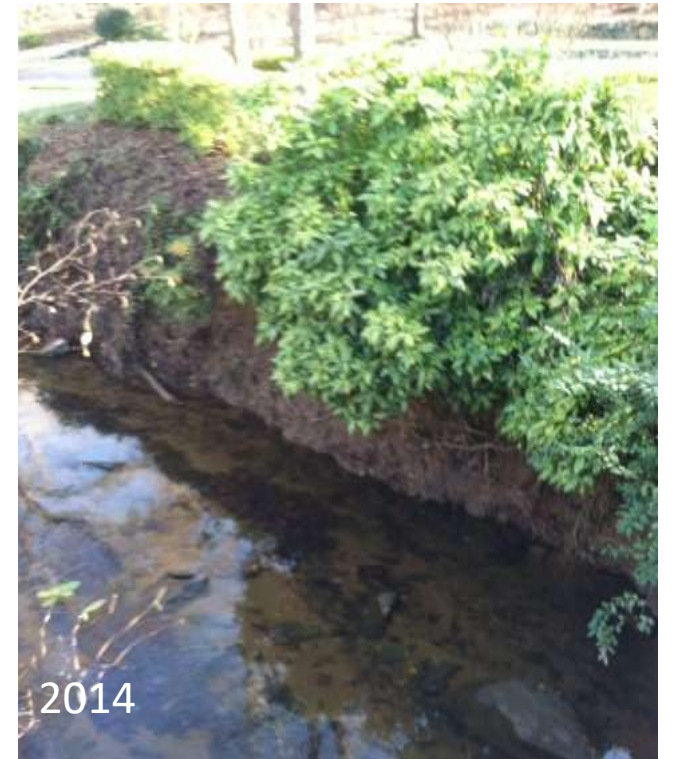
Existing Conditions 2014

- Lack of streambed variation – all run/pool
- No stream vegetative cover (high stream temperatures in extreme heat)
- Heavy erosional forces and loss of streambank

- Lack of instream habitat
- No LWD – large woody debris

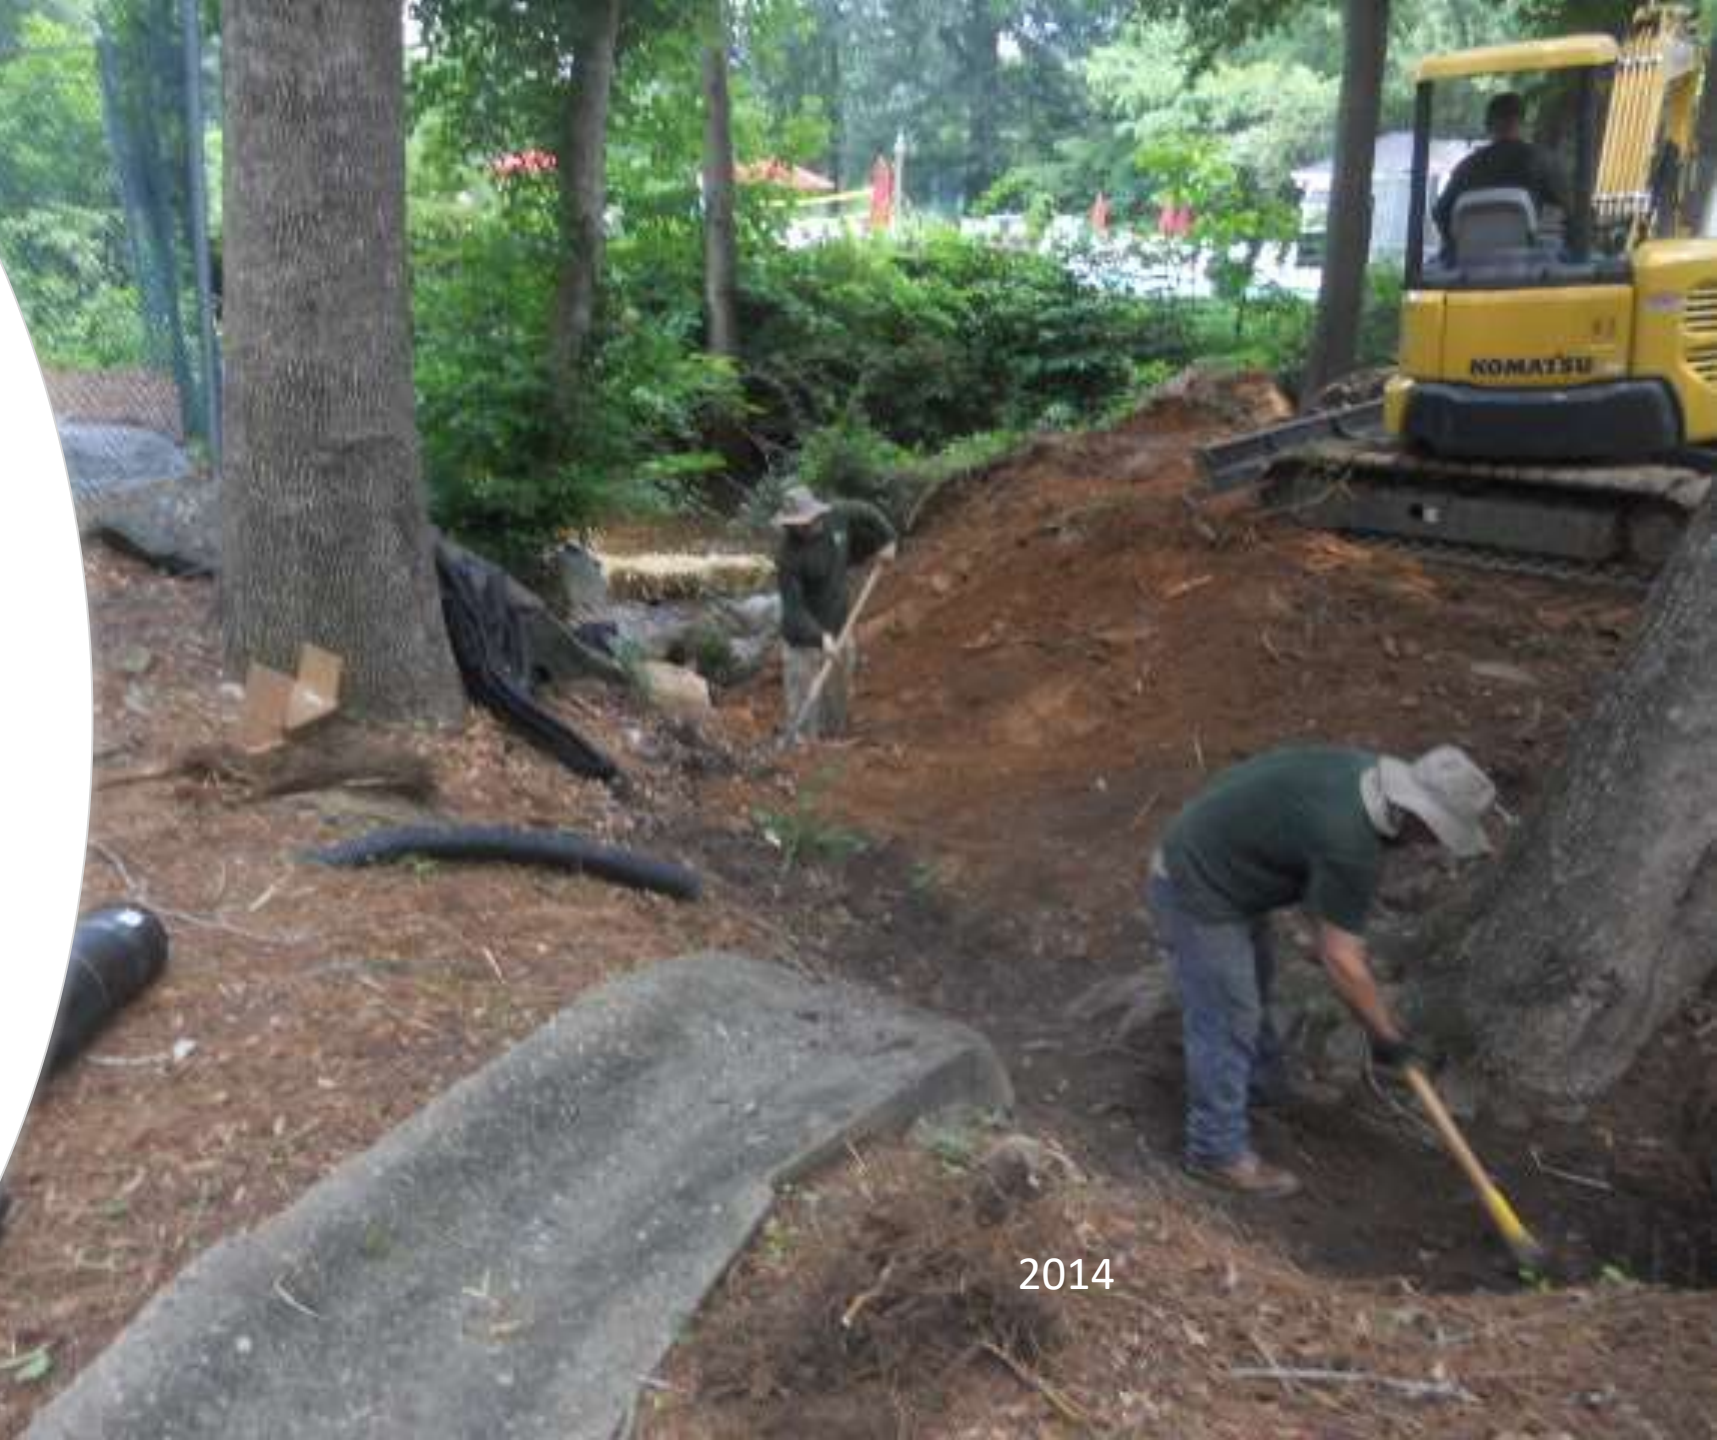
2014 Existing Conditions

- Ephemeral channels – increase stormwater flow unrestricted actively eroding right bank (pool property)
- Direct runoff from streets
- Heavy sediment deposition from roadway runoff
