High Definition Stream Survey Chattahoochee River, GA  
Crayfish Creek Tributary 6/23/2020

# THE HIGH-DEFINITION STREAM SURVEY OF THE CHATTAHOOCHEE RIVER NATIONAL RECREATION AREA, GEORGIA

HIGHLIGHTING A FAST AND FLEXIBLE METHOD TO DOCUMENT STREAM CORRIDOR CONDITIONS LEADING TO RESTORATION ACTIONS

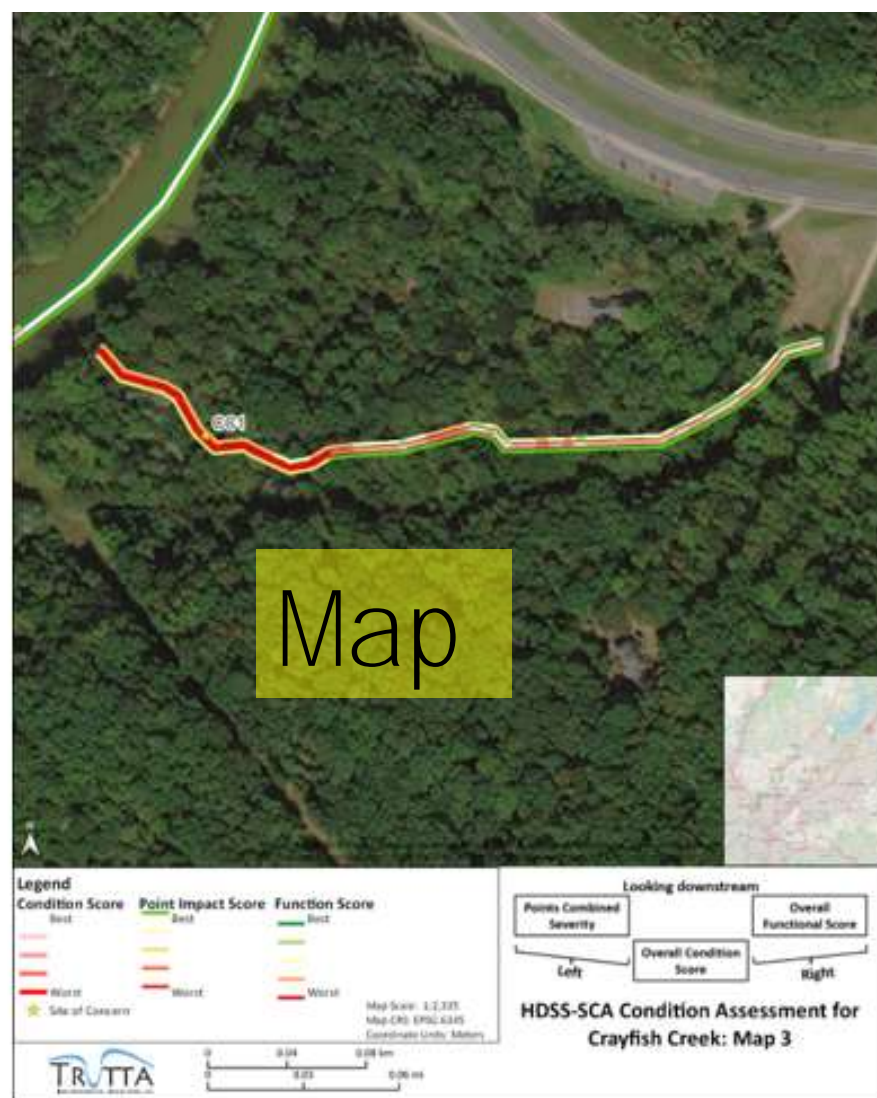
Overall Function in the lower half of Crayfish Creek was affected from excessive stormwater and sediment runoff. Additionally, two defunct culverts and a debris dam worsened the overall condition of the stream resulting in a SOC for this creek (Figure 51). With discrete point features and function

creek (Figure 51). With discrete point features and function combined, the overall condition of Crayfish Creek indicates that this stream has one of the top three worst scores of the tributaries sampled.

Figure 51: Image of Crayfish Creek identifying one SOC (i.e., CC1).

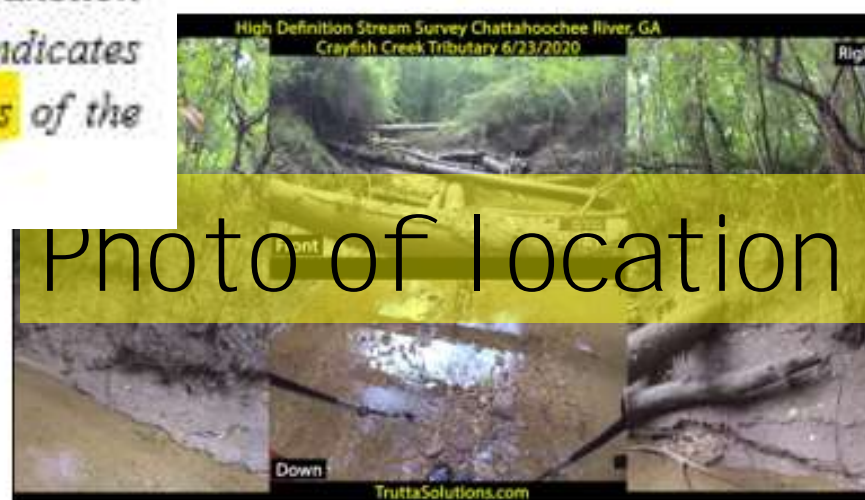
**Site Metrics:** Site of Concern CC1 (Figure 52) occurred in Crayfish Creek (1004), on StreamView video track 1 between the time of 12:13:36 and 12:17:26 and was 465 m long. CC1 had a condition score of 5.0, function score of 3.9, modification score of 1, and a point score of 2.

Figure 52: Image from the CC1 segment of Crayfish Creek observed on 6/23/2020 at 12:16:57.

**Problem:** The CC1 segment of Crayfish Creek is located in the lower downstream portion of the surveyed stream and had both functional and discrete point features documented. This segment had streambanks actively eroding and collapsing (Figure 52) into the stream. Also, the streambed was over-widened and filled with fine sediment. A debris dam and defunct culverts (Figure 53) exacerbated the overall condition of stream by constricting discharge that increased the erosive forces during high flow events. In addition to the active channel failure and the discrete point features listed above an additional 10 unique point features were also documented along this SOC, consisting of LWD (n=8) and in channel bars (n=2); however, they have minor or negligible impact directly on the stream channel. A small section streambed (approximately 4 m) was classified as modified due to the presence of the deteriorating culverts.

**Problem Cause:** Crayfish Creek overall appeared to suffer from stormwater and sediment runoff related issues. Development in the upper portions of the watershed have led to excessive stormwater and sediment in the lower portions of stream. The increased frequency and magnitude in flow volumes during heavy rainfall events exceed the natural capacity

of the stream and therefore cause excessive erosion along the streambanks. The debris jams and culverts continue to worsen the condition of the stream by concentrating high flow that continue to degrade the area and prevent the reestablishment of stable streambanks and streambed. It should also be noted that power peaking discharges from Buford Dam also generates backwater jacking and intrusion in the lower reaches of Crayfish Creek leading to downcutting.

**Restoration Approach:** This area may require two separate restoration approaches. The first restoration activity would be a channel restoration designed to effectively transport water during high flow events and pass sediment through the system. The specifics of this restoration action are difficult to determine due to the fact that the dominant problems influencing the stream are upstream of the survey area. Emphasis for mitigation efforts directed to stormwater and sediment detention in the upper watershed are warranted.

The second approach would be the removal and disposal of the debris dam and defunct culverts. This would reduce the local constriction created in this area, thus reducing the water force and erosive power. Only accomplishing this second activity in the absence of the first, will likely make natural restoration of this area in the long term unlikely. Final project design would incorporate stormwater flow and sediment detention, channel stabilization as well as grade control measures near its confluence with the Chattahoochee River.

**Access:** Moderate to difficult. This area would be accessed through a heavily wooded area; however, satellite images suggest a potential access road/cutting directly south of the SOC. This would allow access for heavy equipment that may be needed in the restoration effort. Access on foot would be easy to moderate since it may require a quarter mile trek.

**Correctability:** Moderate to difficult. The mitigation of stormwater runoff problems requires modifications upstream of this location and/or substantial channel restoration efforts at this site. It is likely to require extensive design and planning and the use of heavy equipment in the restoration efforts. Solely removing and disposing the defunct culverts will likely require small machinery and/or power tools.
