Fairfax County, Virginia

Piney Run at Lake Werowance Stream Restoration

Section 1. Project Overview

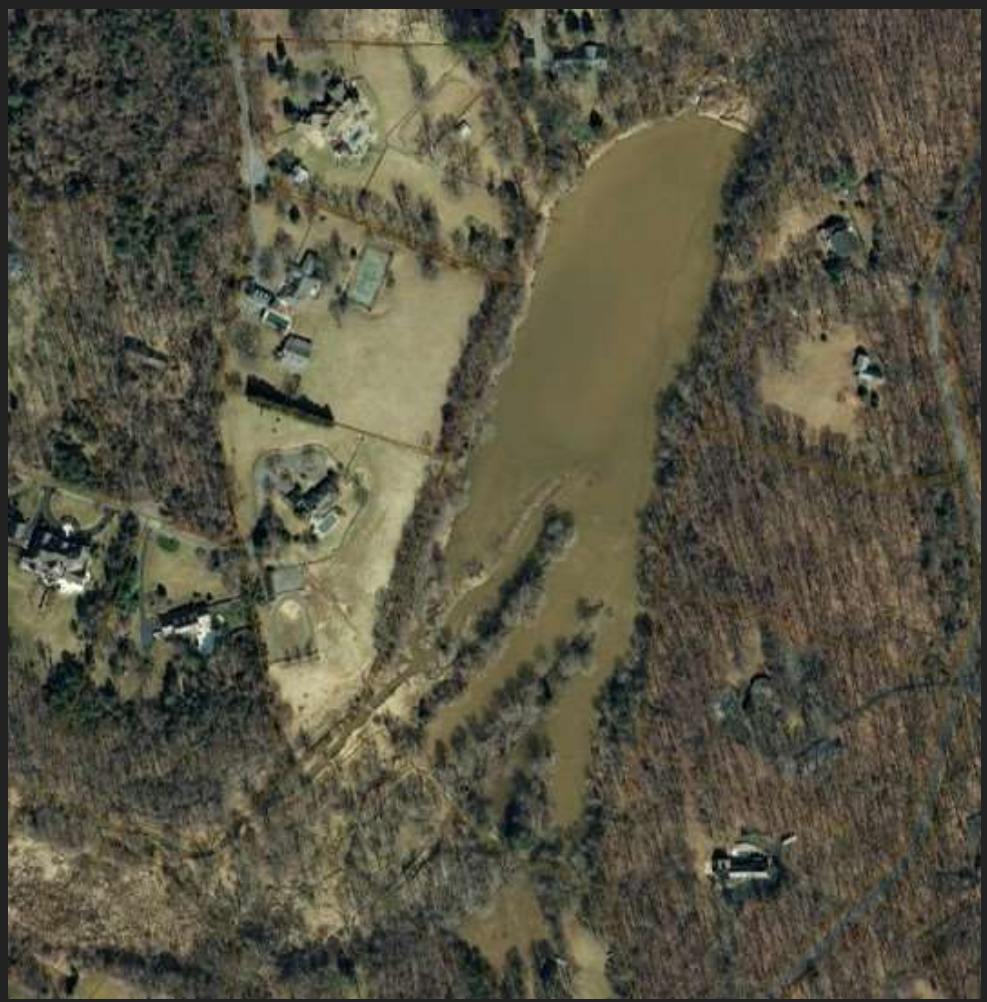
2011 (pre- dam breach)

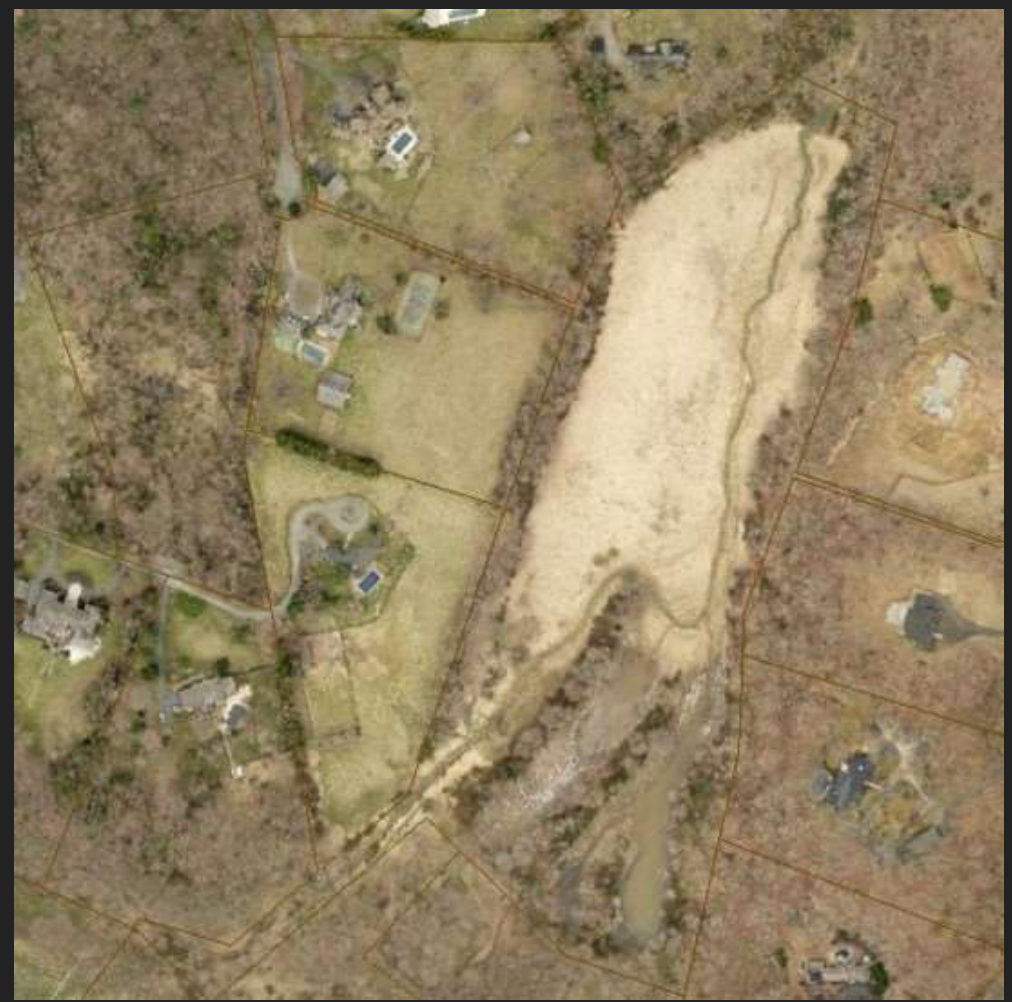
2019 (post- dam breach)

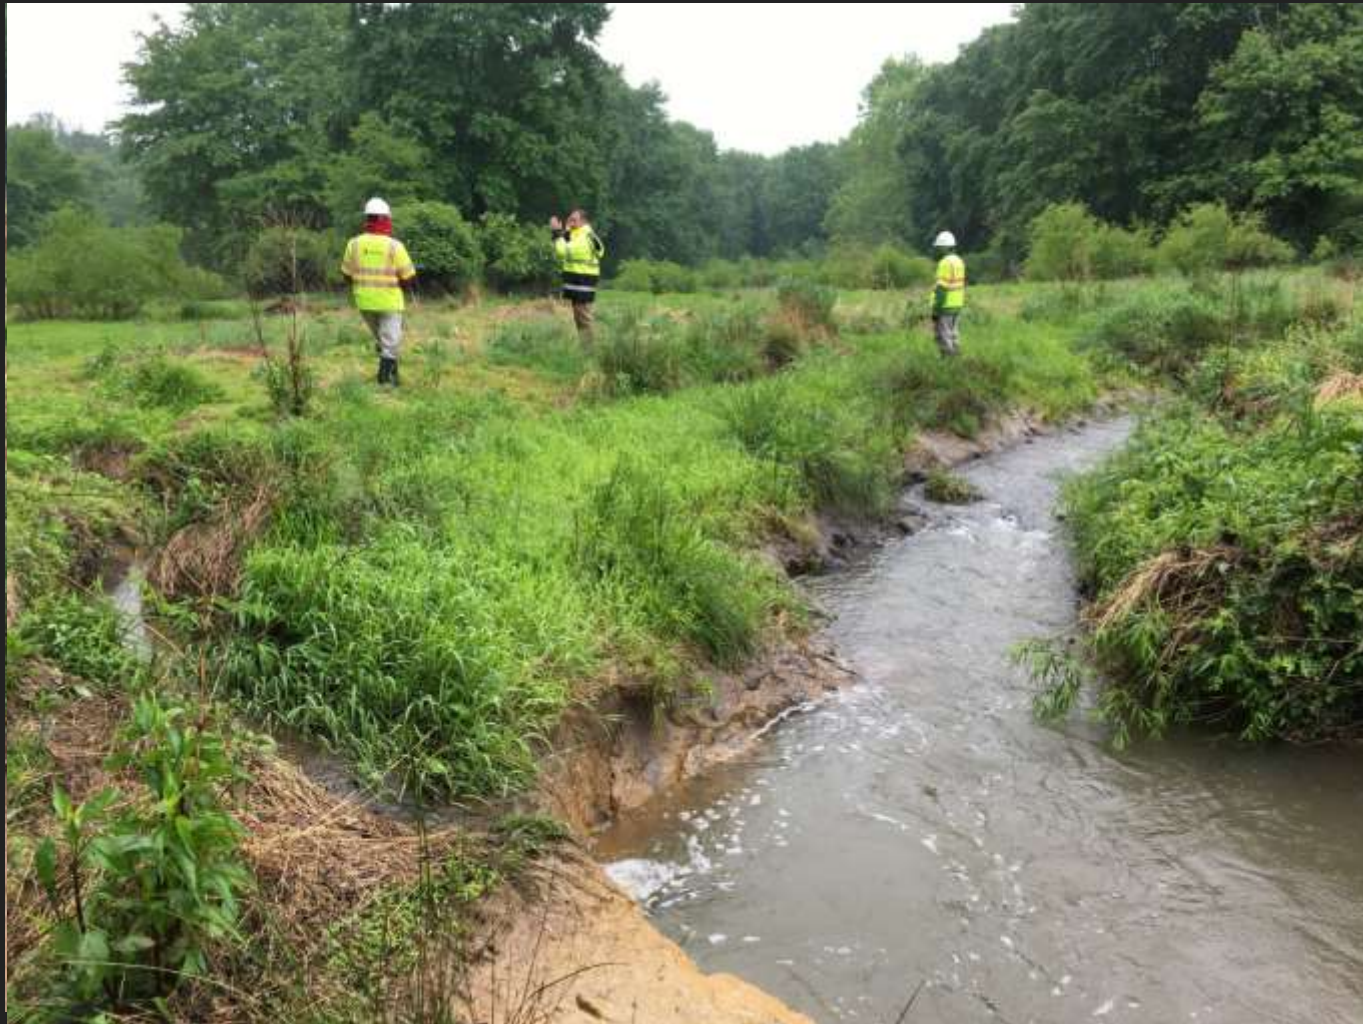
Former Lakebed: Piney Run at Lake Werowance

Conversion of lakebed to interconnected stream & wetland system

- Construct meandering stable stream system that provides hydrology to complex wetland network
- Construct network of functional floodplain wetlands and open water features throughout lakebed

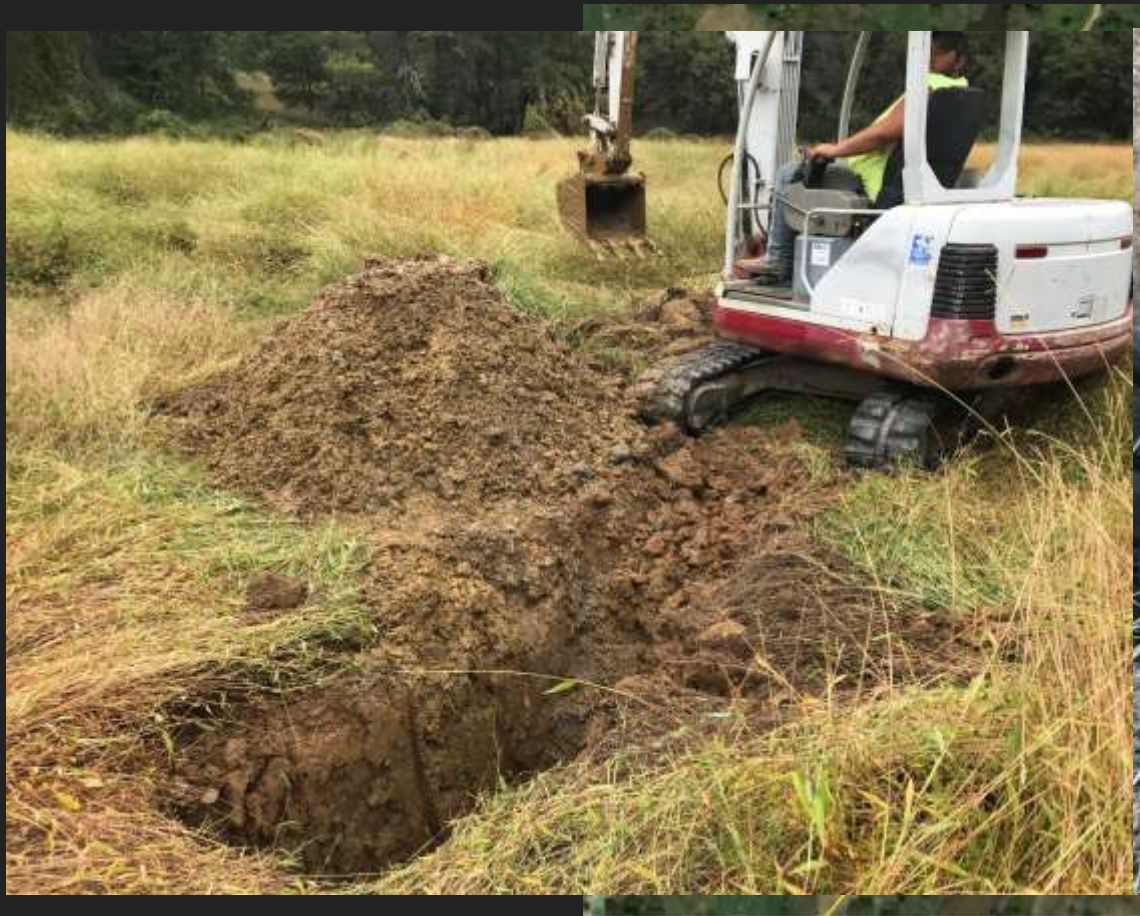
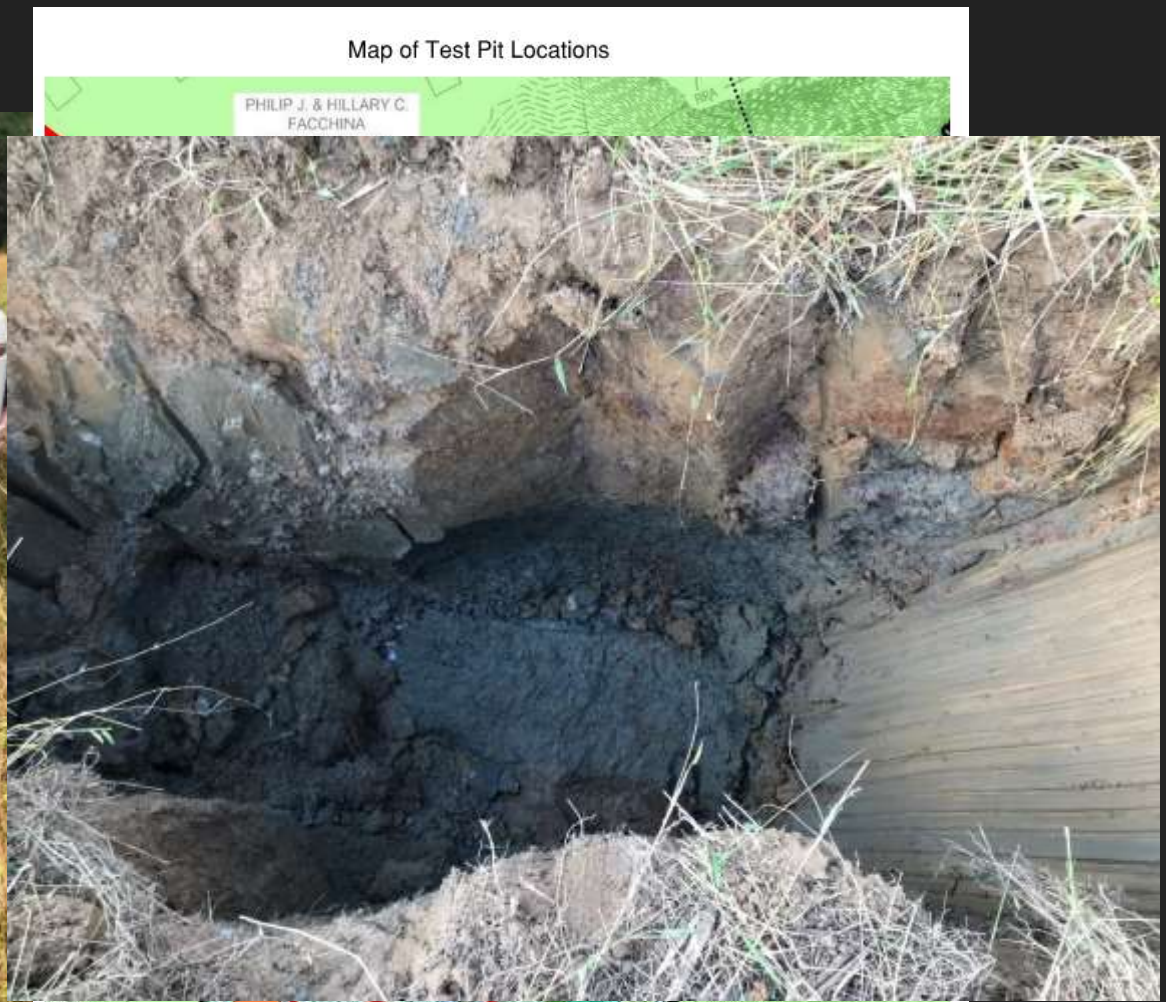
Soil Deposits in Lakebed

Map of Test Pit Locations
PHILIP J. & HILLARY C. FACCHINA

10/3/2019 Test Pits
10/4/2019 Test Pits

Deposition in lakebed
