Case Study: Marylea Farm Stream Restoration Site Biological Monitoring

by: Mike Fowler and Carolyn Lanza

- **LOCATION:** Bel Air, Maryland
- **RIVER BASIN:** Susquehanna
- **ECOREGION:** Piedmont Uplands
- **WATERSHED SIZE:** 5.8 sq. miles
- **LENGTH:** ~9,800 LF of stream restoration
- **GOAL:** Reduce sediment and nutrient inputs to the Chesapeake Bay

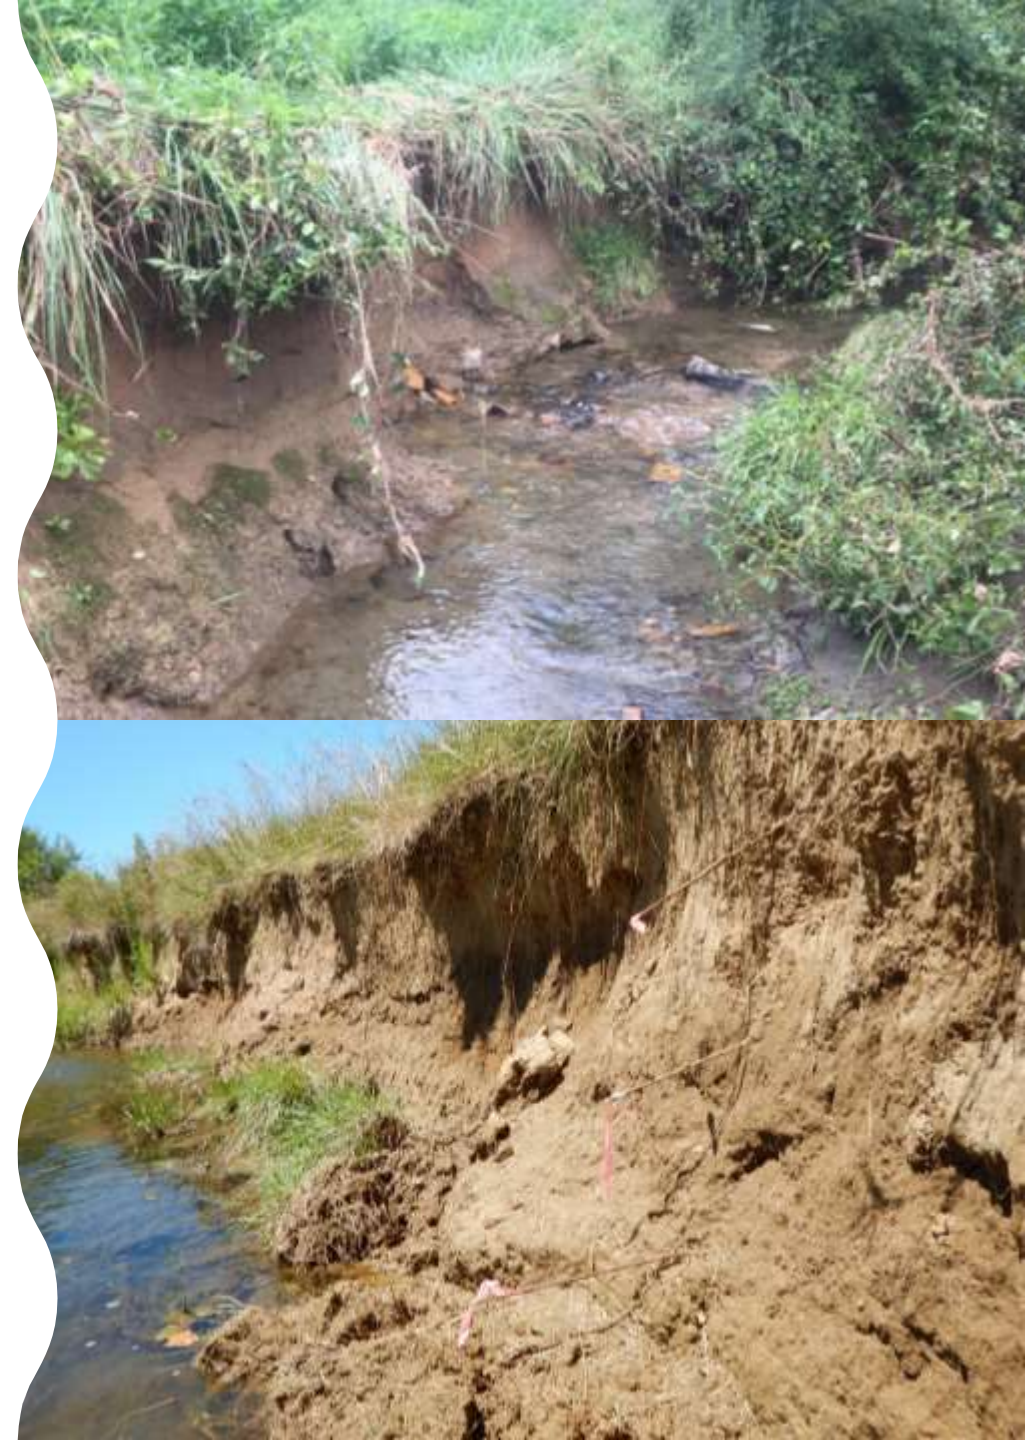
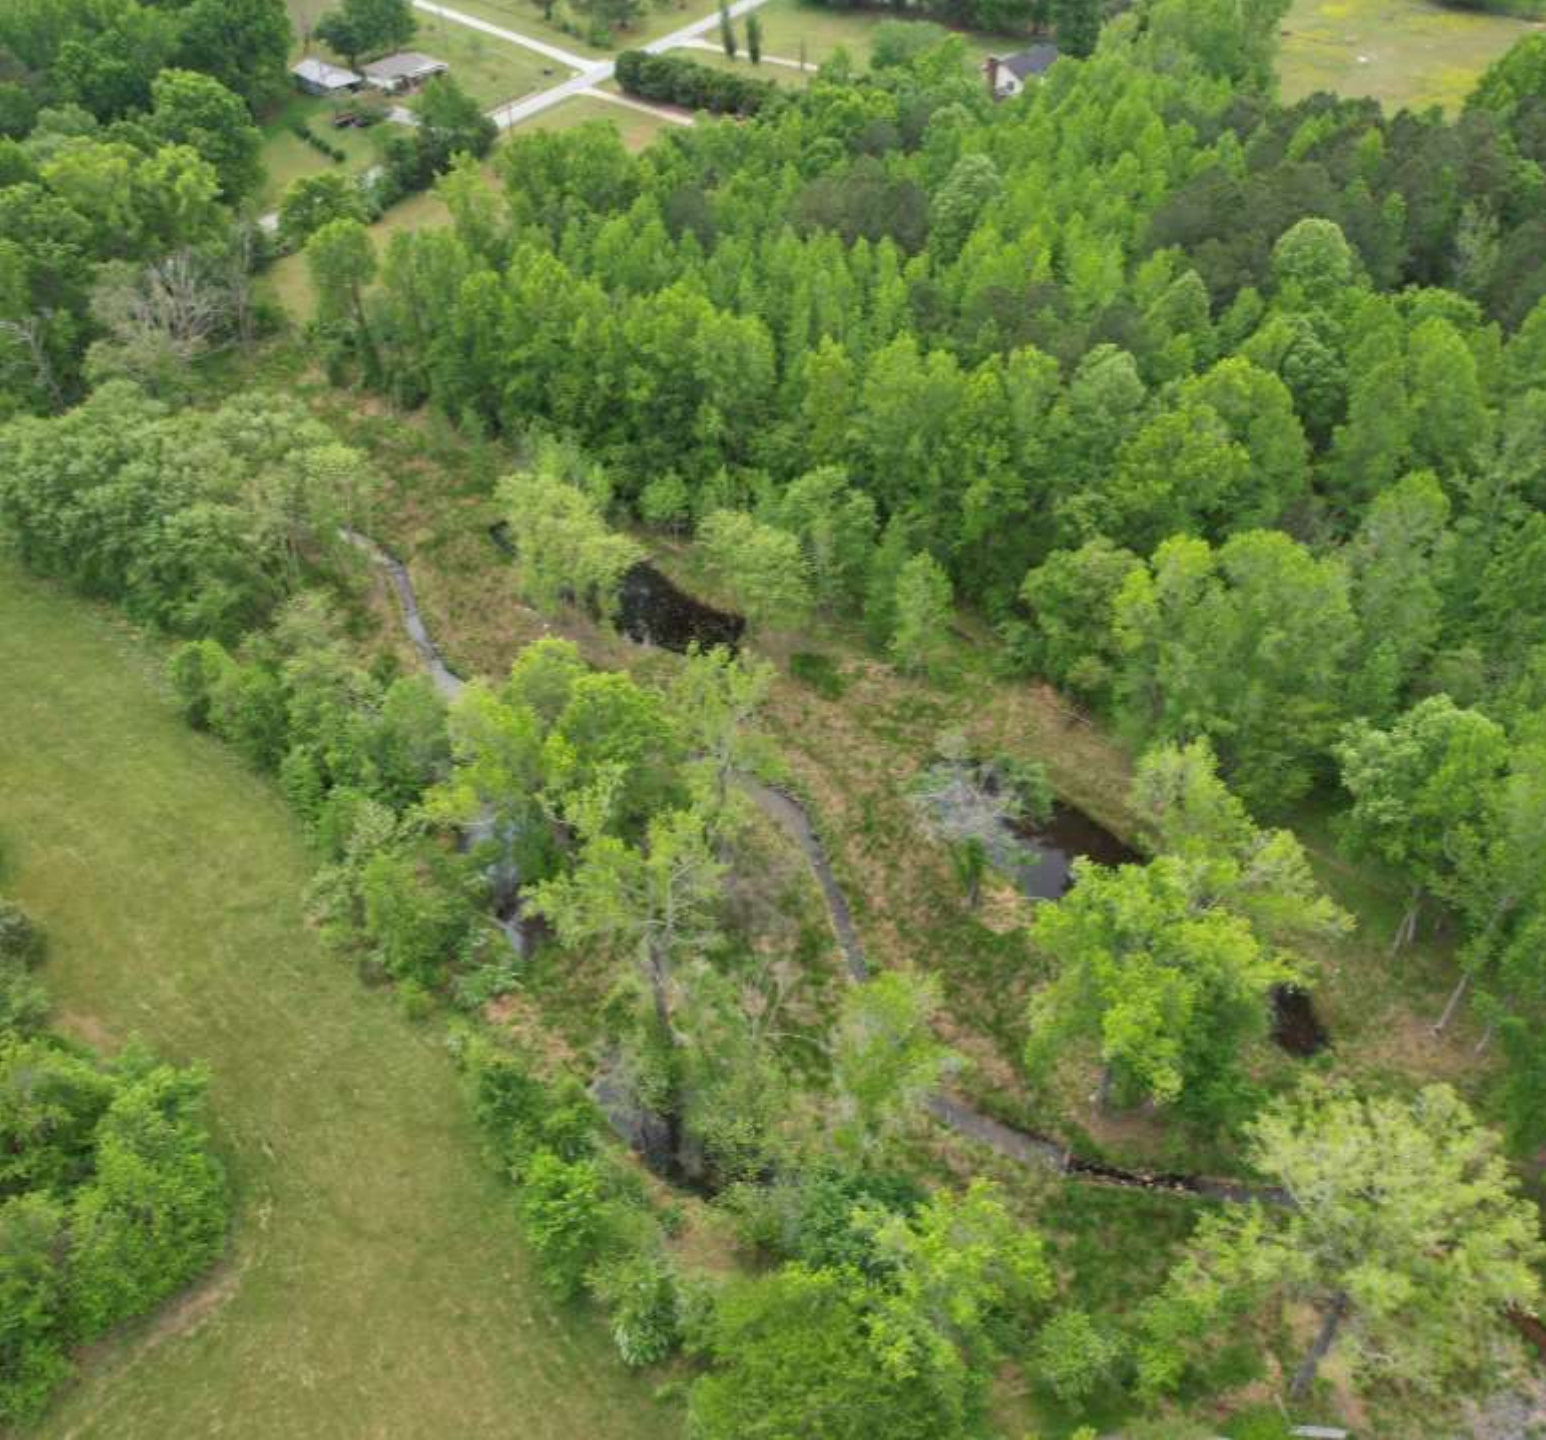
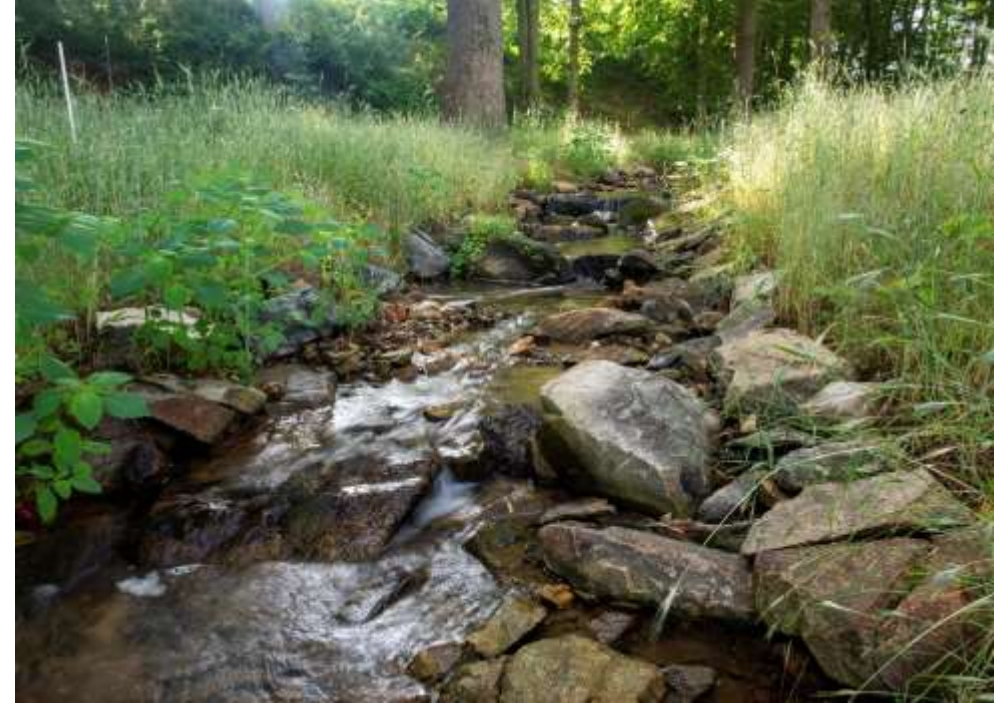
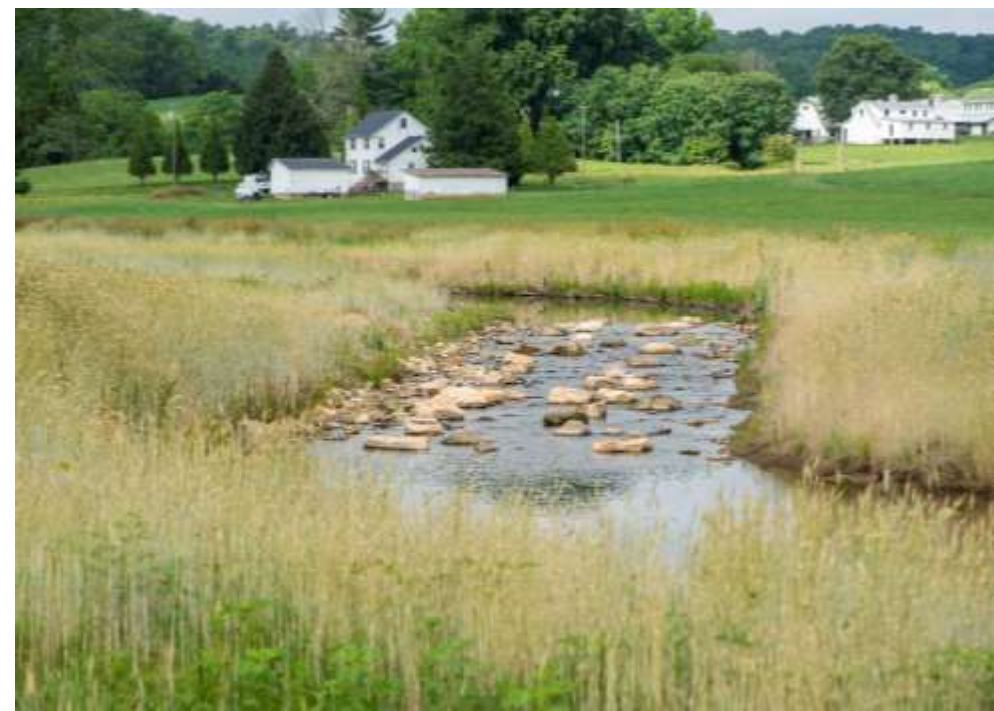
Existing Conditions

- Extensive channelization
- Mass wasting and severe erosion in meandering sections
- Unvegetated banks and complete lack of riparian buffer
- Moderate to severe incision

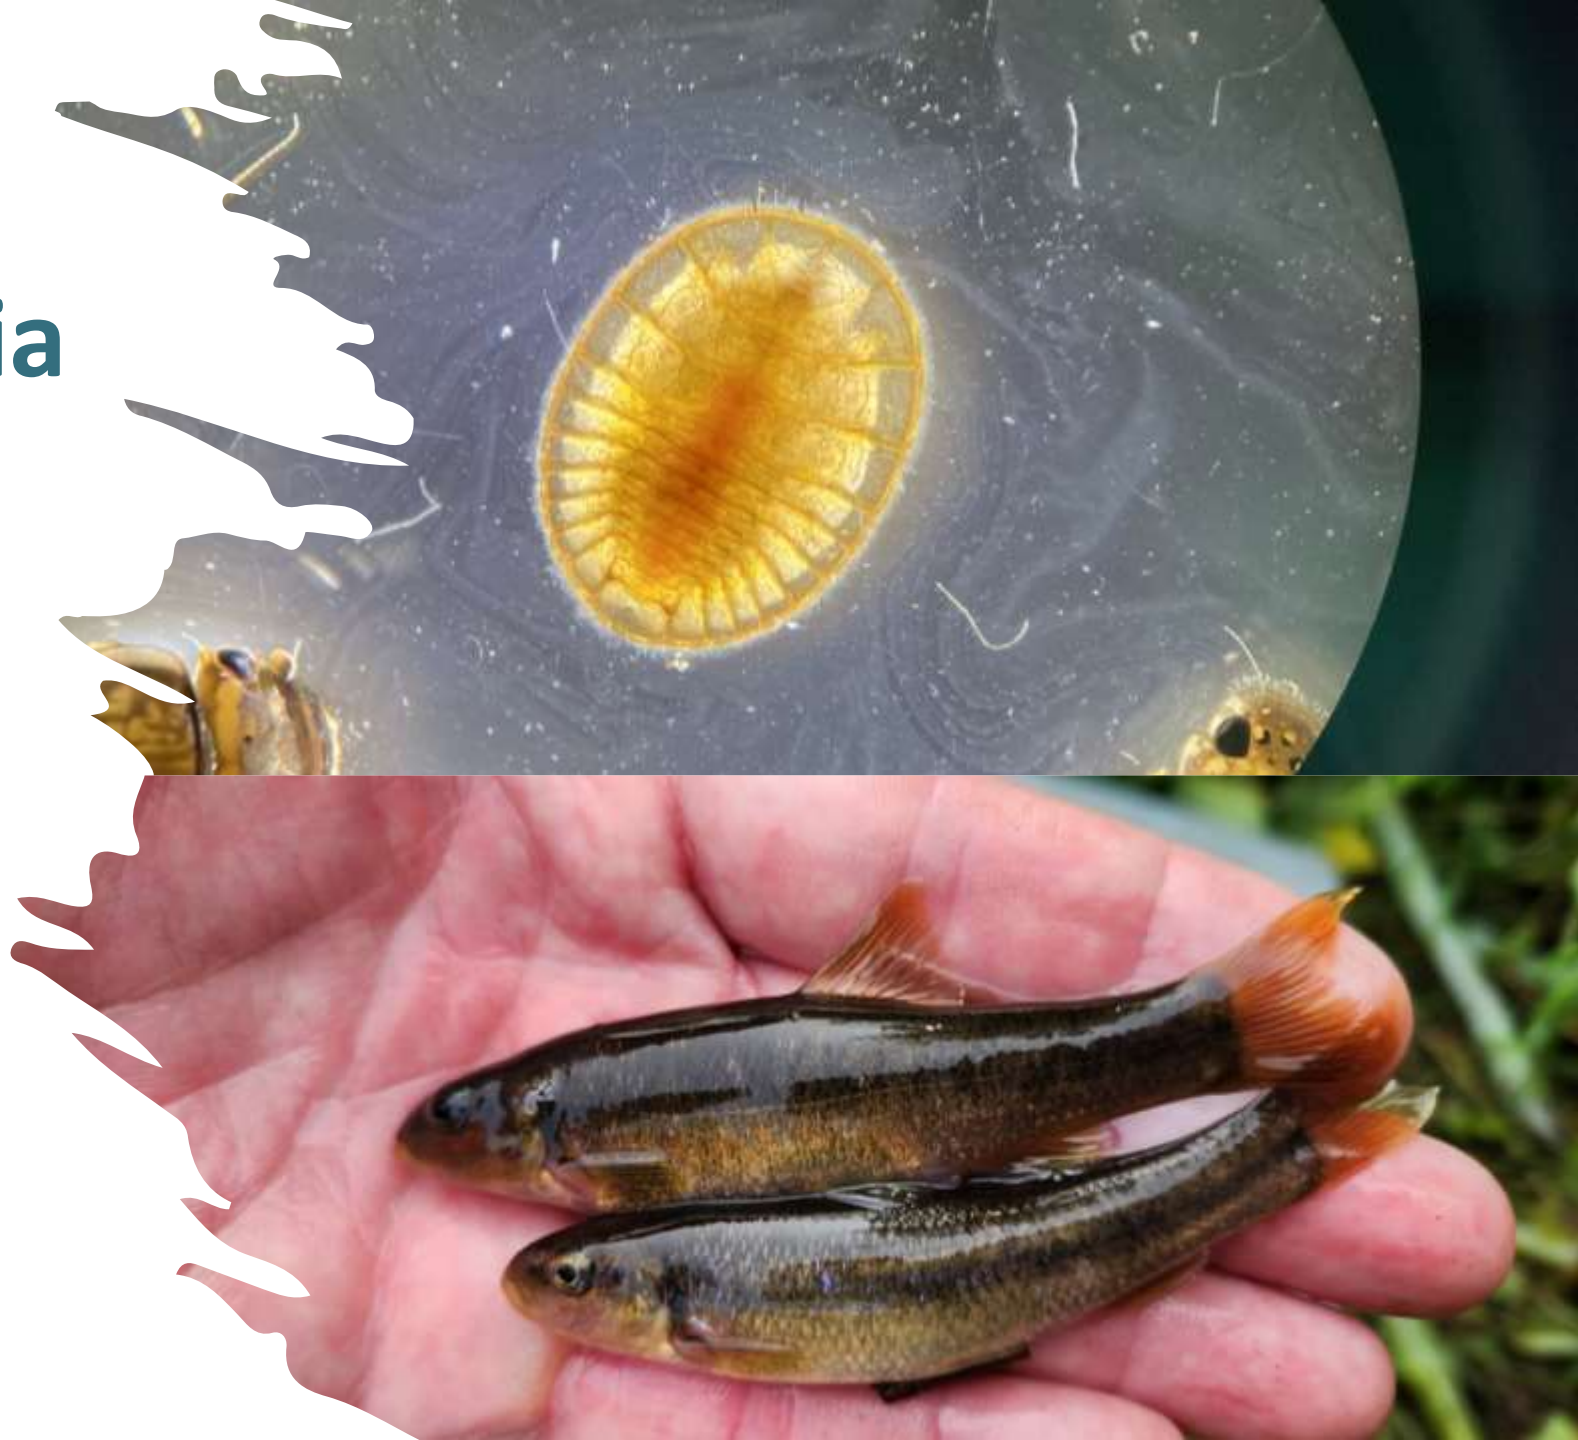
Maryland Biological Criteria

- Maryland permits did not require biological sampling at the time of permit review in 2019
- Now benthic macroinvertebrate pre-construction sampling on all perennial streams required to receive joint permit application
- Sampling not required post-construction per monitoring requirements

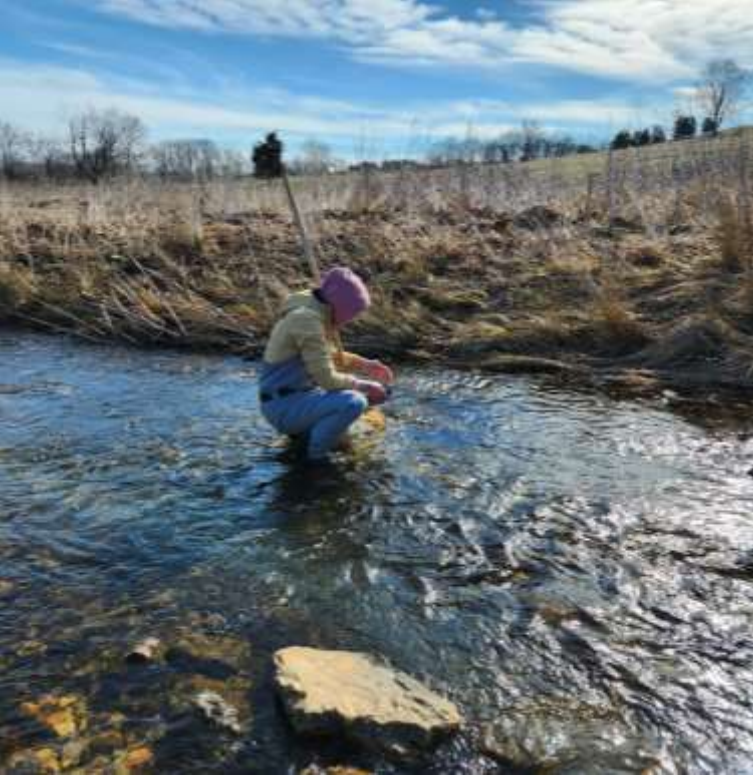
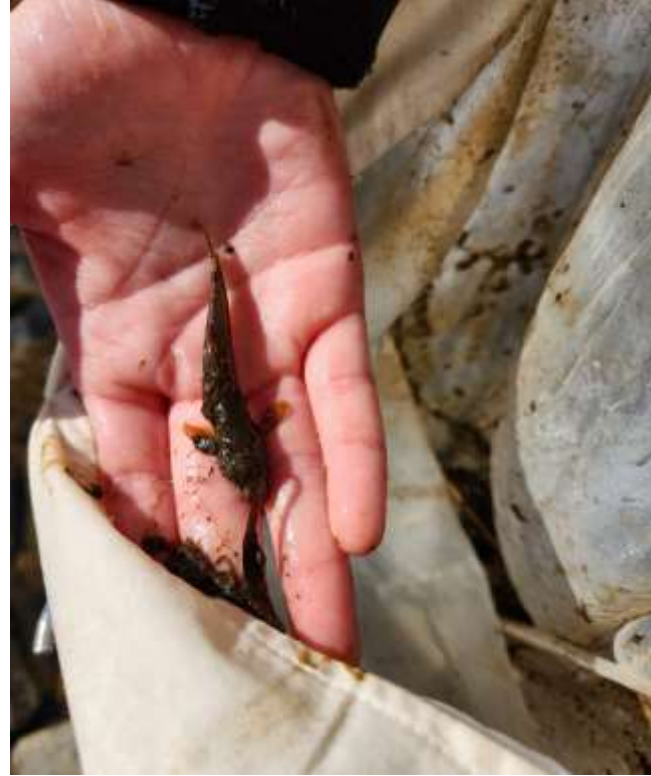
Methods

Proper benthic macroinvertebrate
Maryland Biological Stream Survey
training and Scientific Collection Permits
for fish

MBSS: Round Four Field Sampling Manual
(MD DNR, 2019)

Water quality parameters for benthic
sampling: DO, pH, temperature,
conductivity

IDs completed by a licensed taxonomist
and certified fisheries professional
