CAT BRANCH STREAM/VALLEY RESTORATION, SWM POND RETROFIT, AND OUTFALL RETROFIT

**National Stream Restoration Conference
Session B: Headwaters and Floodplain Reconnection
August 22, 2023**

**BayLand Consultants & Designers, Inc.
Sean Crawford, PE
Caitlin Sporik, PE**

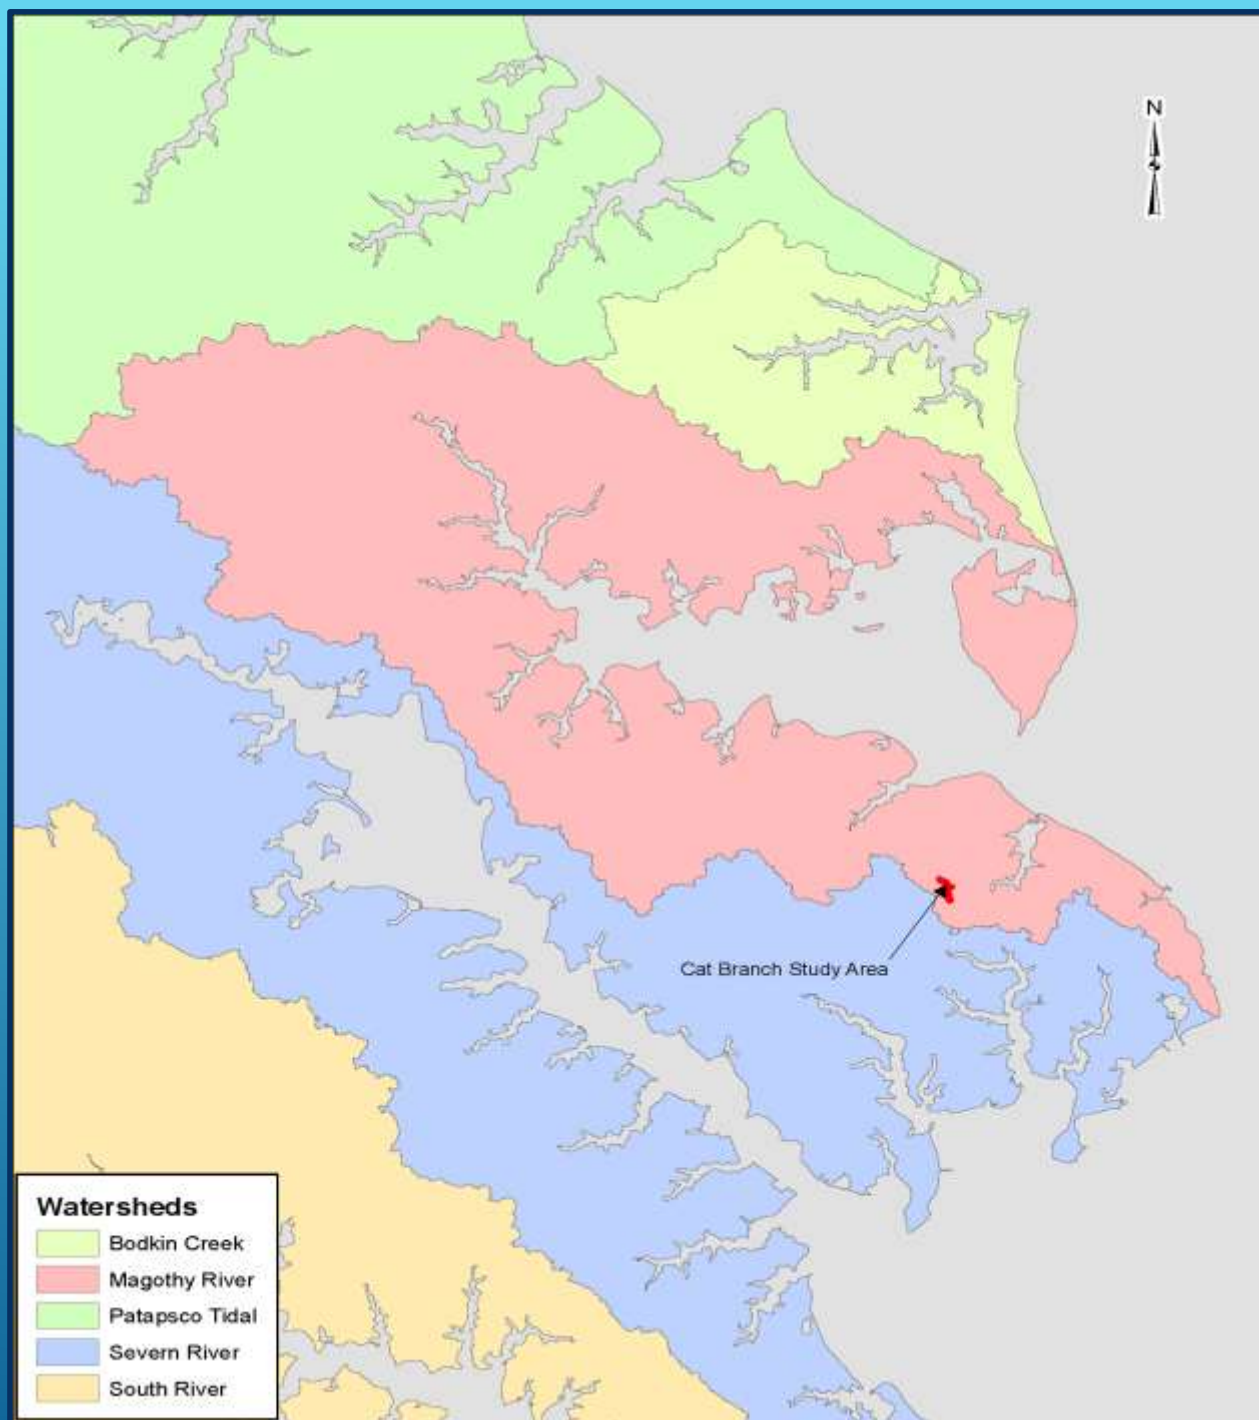
PROJECT LOCATION

Magothy River Watershed

- ▶ 35.6 square miles
- ▶ Mix of urban residential, commercial, and forested land use
- ▶ Part of the Chesapeake Bay TMDL to address Nitrogen, Phosphorus and Sediment

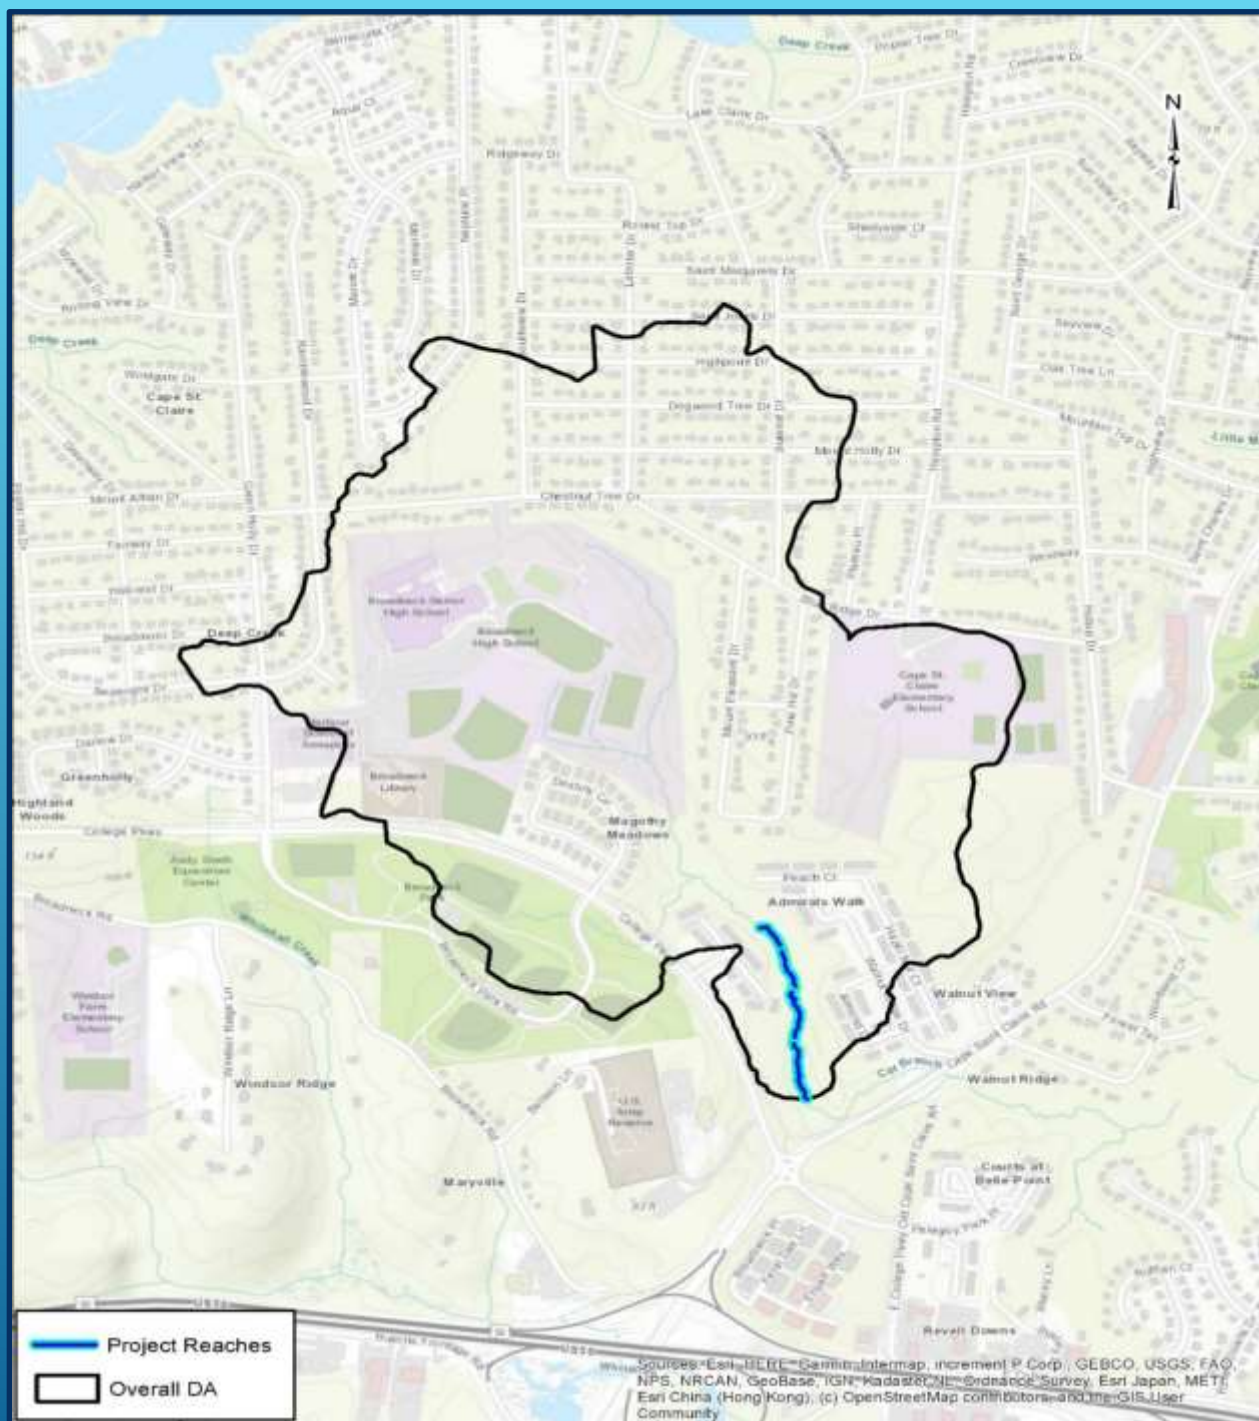
PROJECT LOCATION

Cat Branch Sub-Watershed

- ▶ 285 acres/0.4 square miles
- ▶ 24% Impervious Area
- ▶ Primarily Medium Density Residential and Institutional Land Use

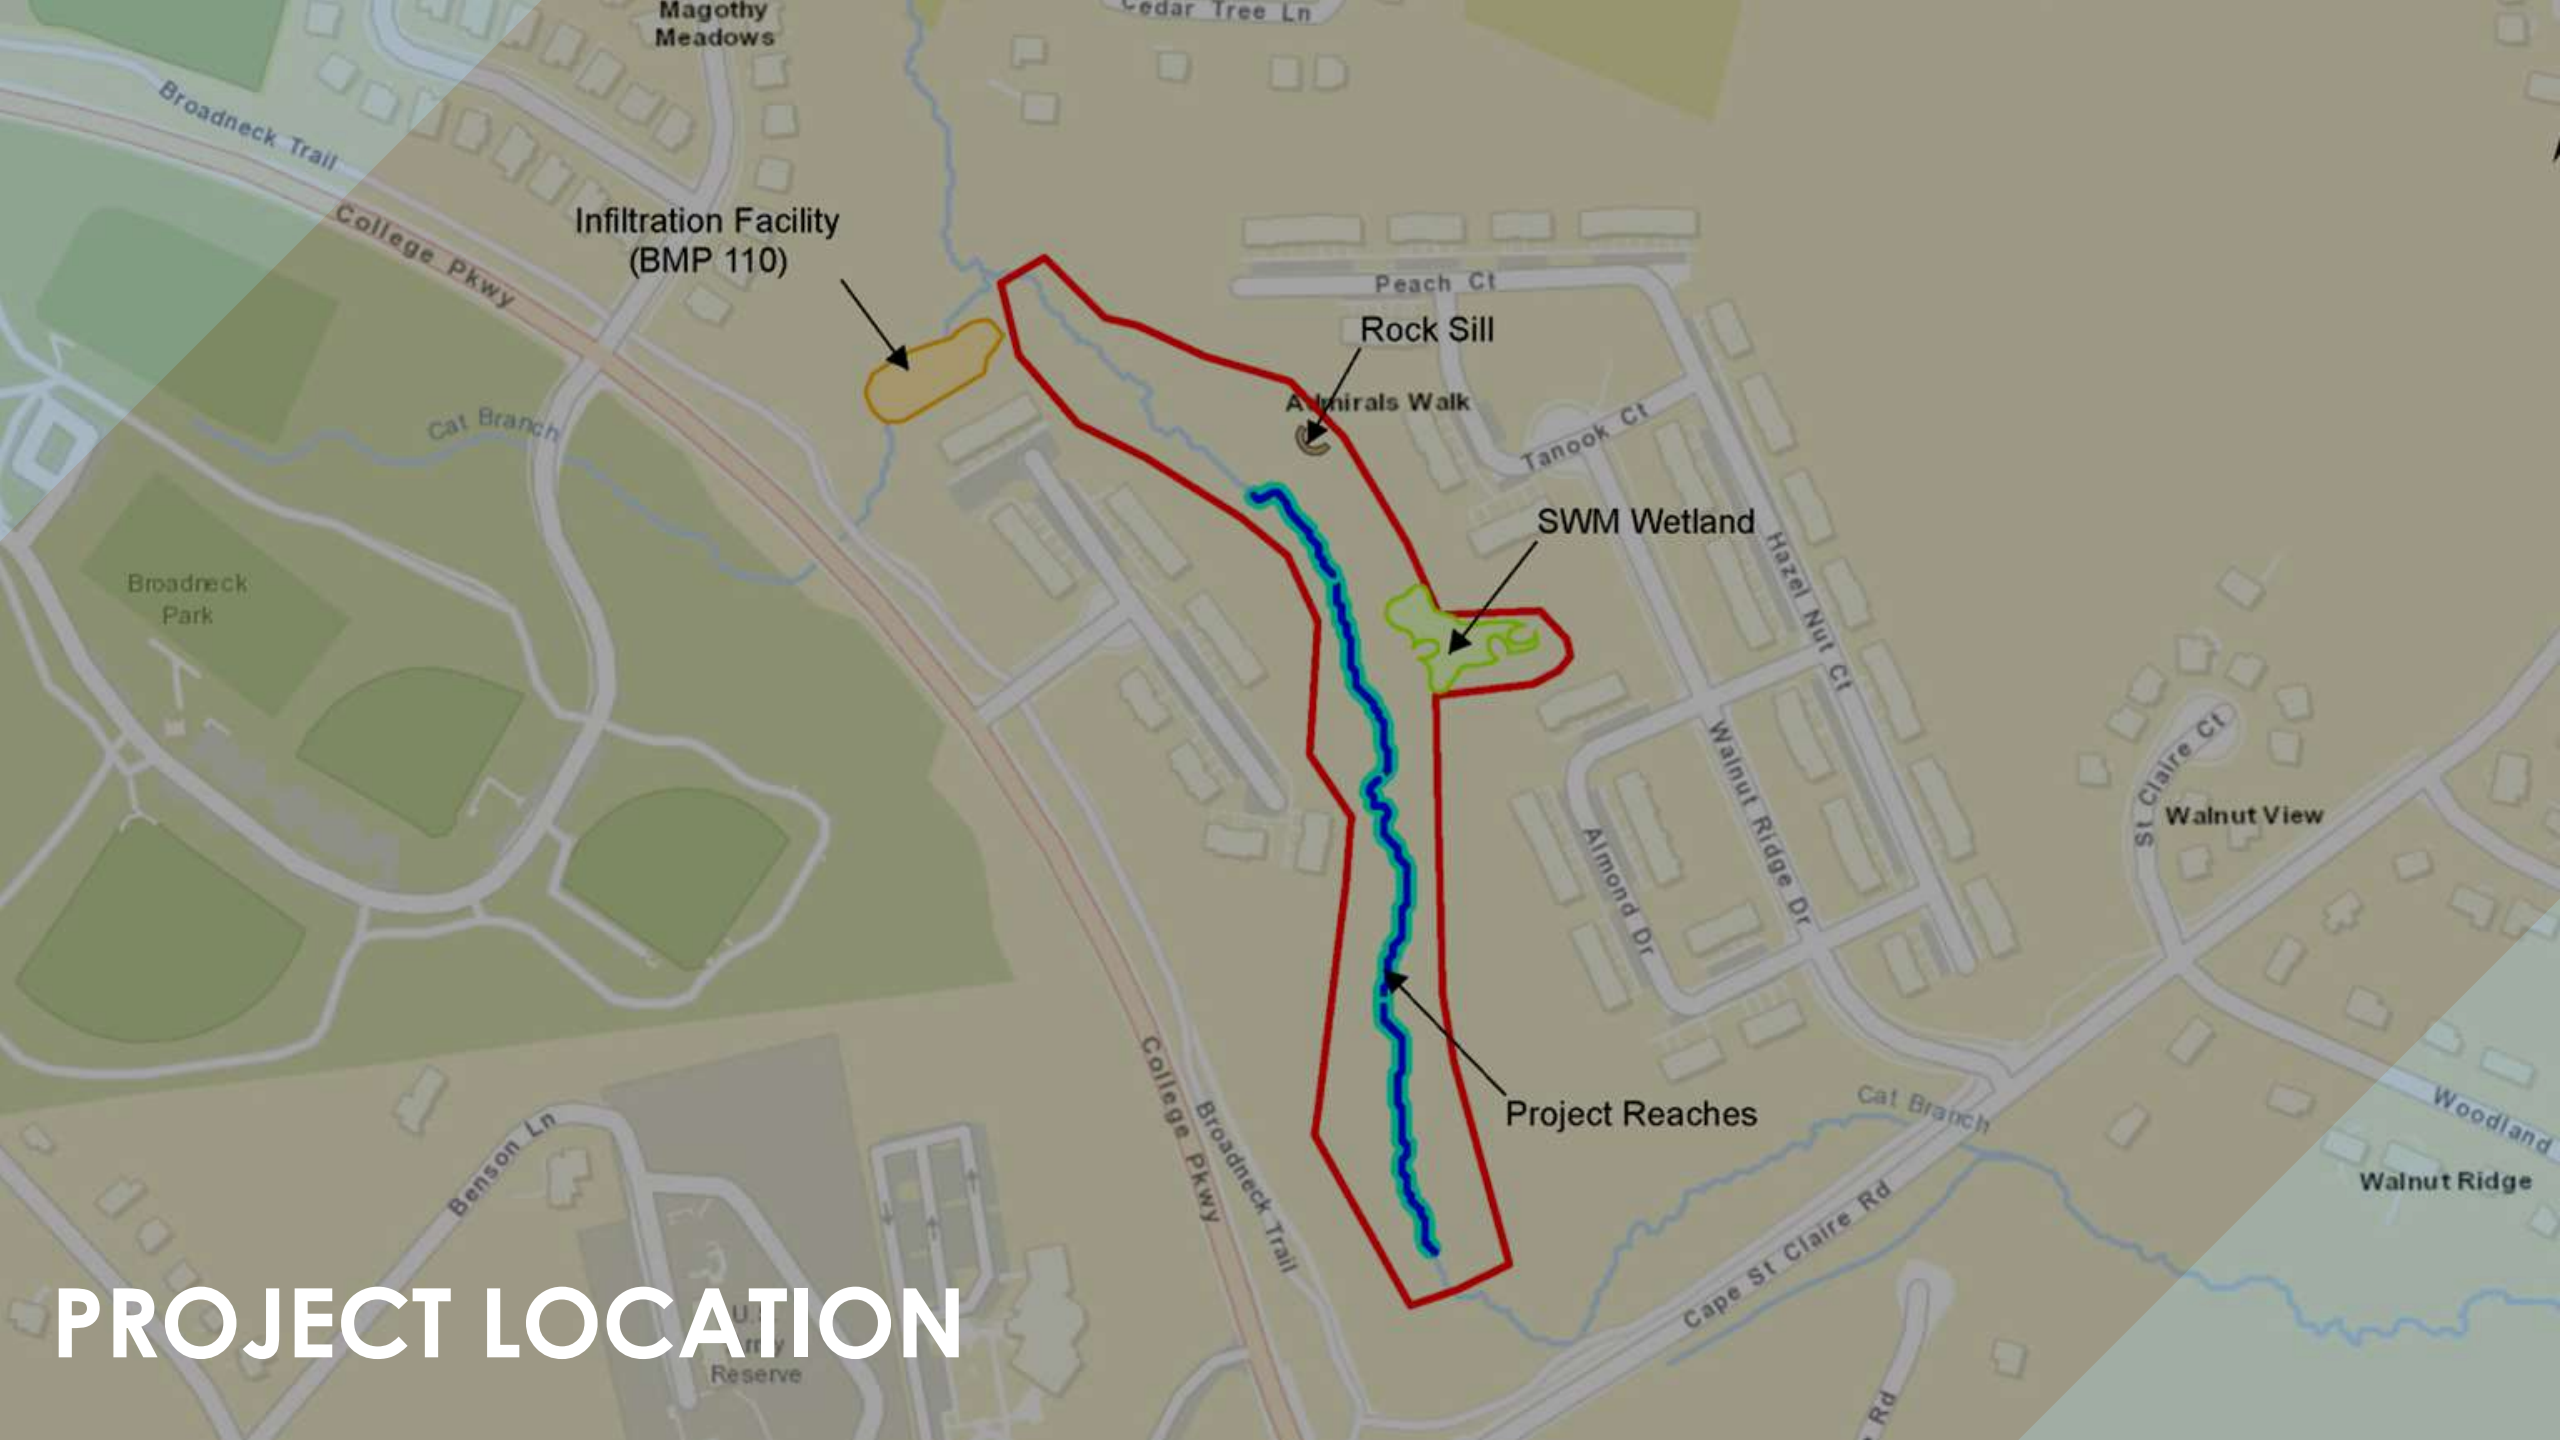
PROJECT LOCATION

Infiltration Facility
(BMP 110)

Rock Sill

SWM Wetland

Project Reaches

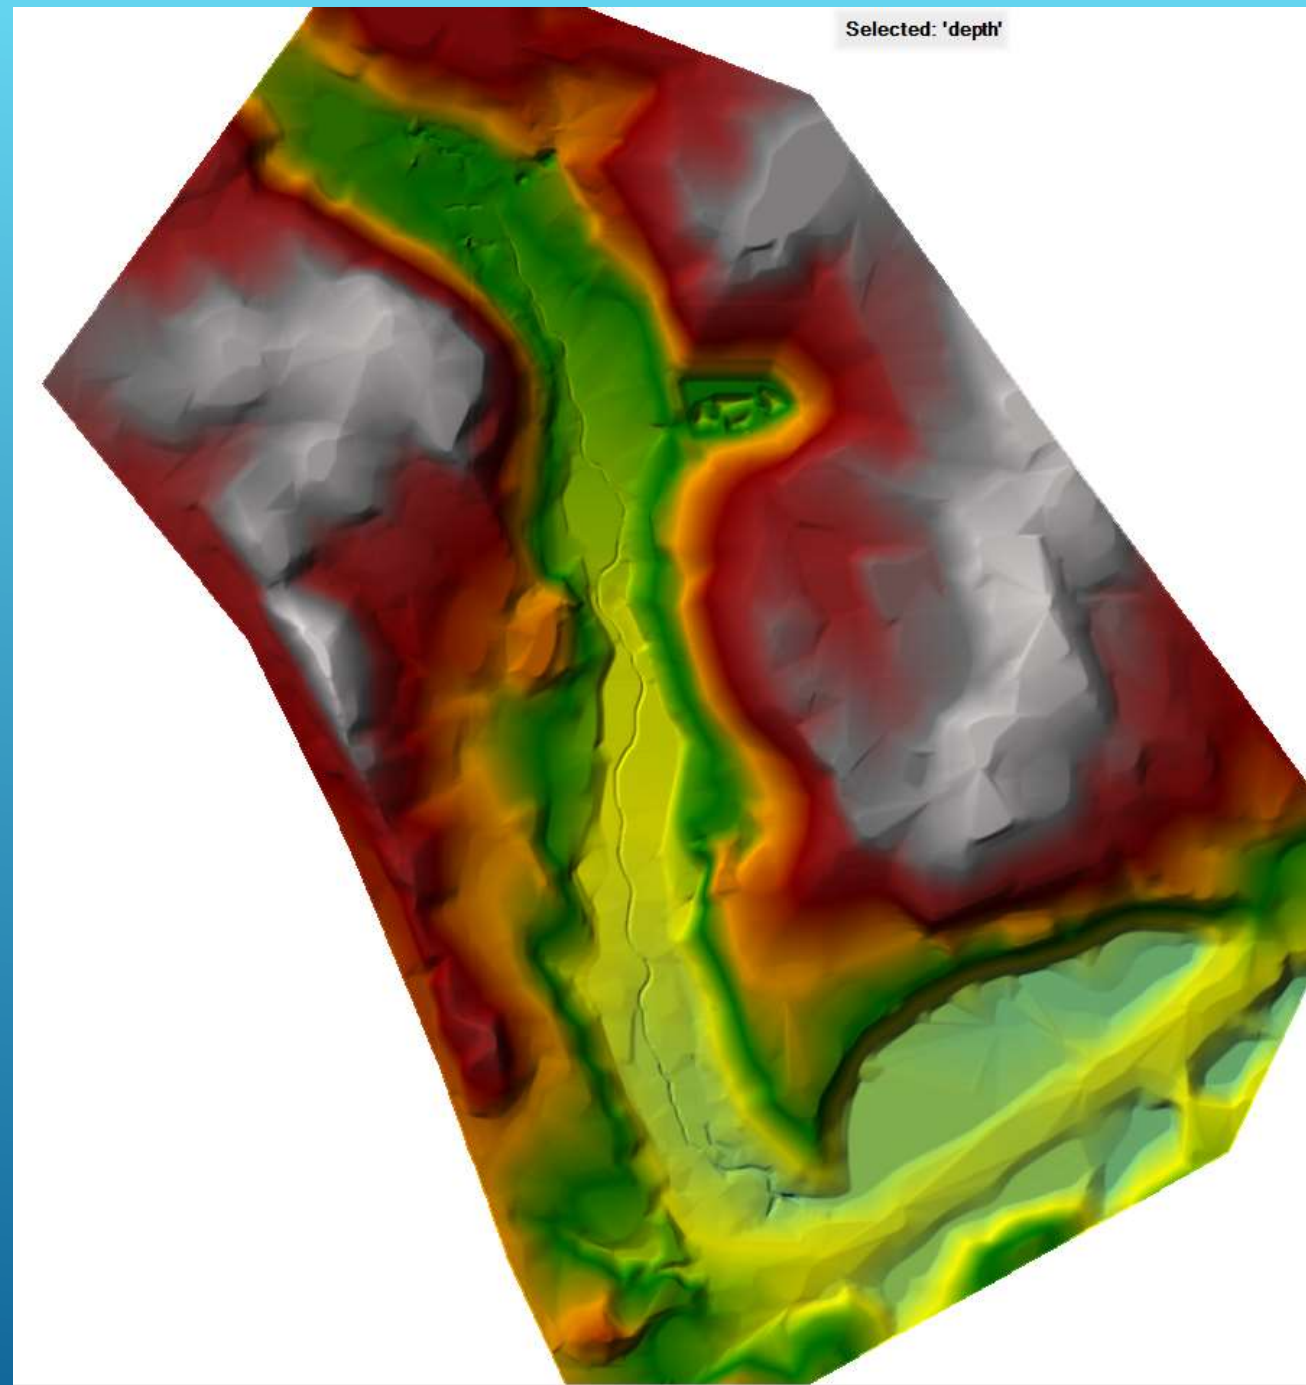
HYDRAULIC MODELING

Two dimensional (2D) unsteady flow modeling conducted to:

- ▶ Evaluate complex channel/floodplain interactions
- ▶ Determine near-field detail flood patterns
- ▶ Support restoration design
