All Woody Streambank Stabilization

Restoration on HOA Budget

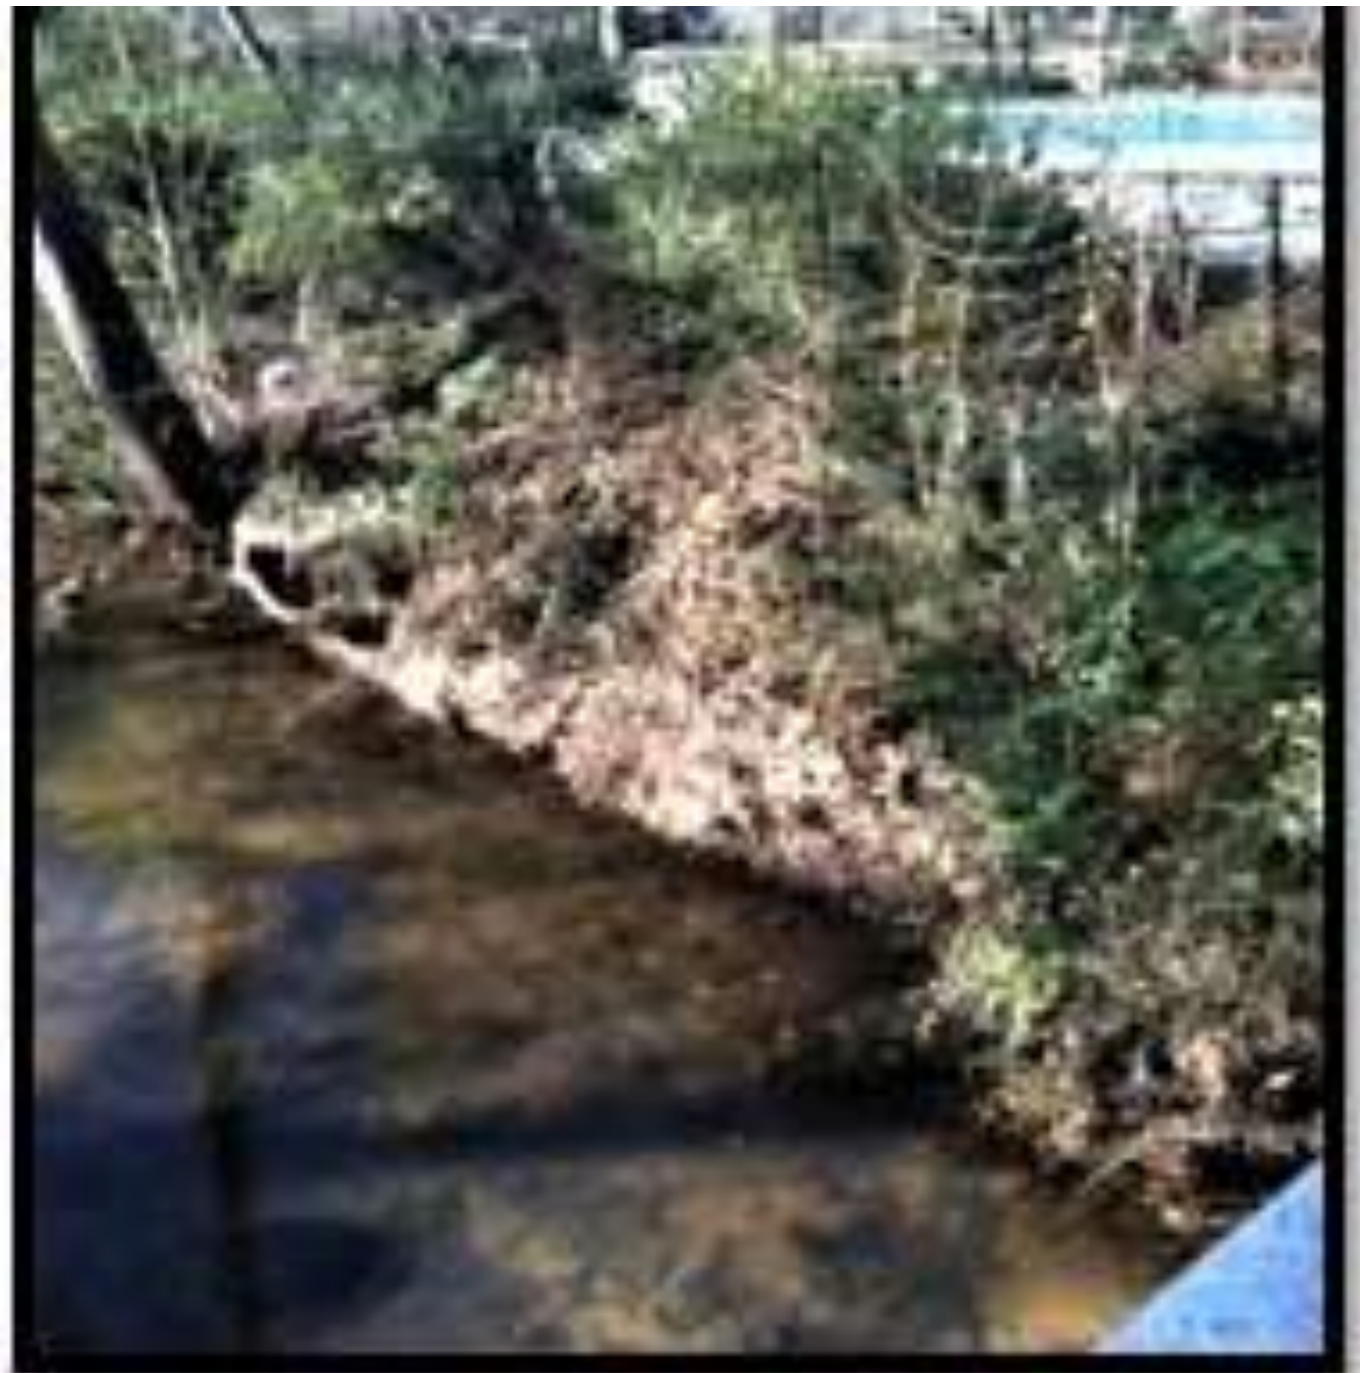
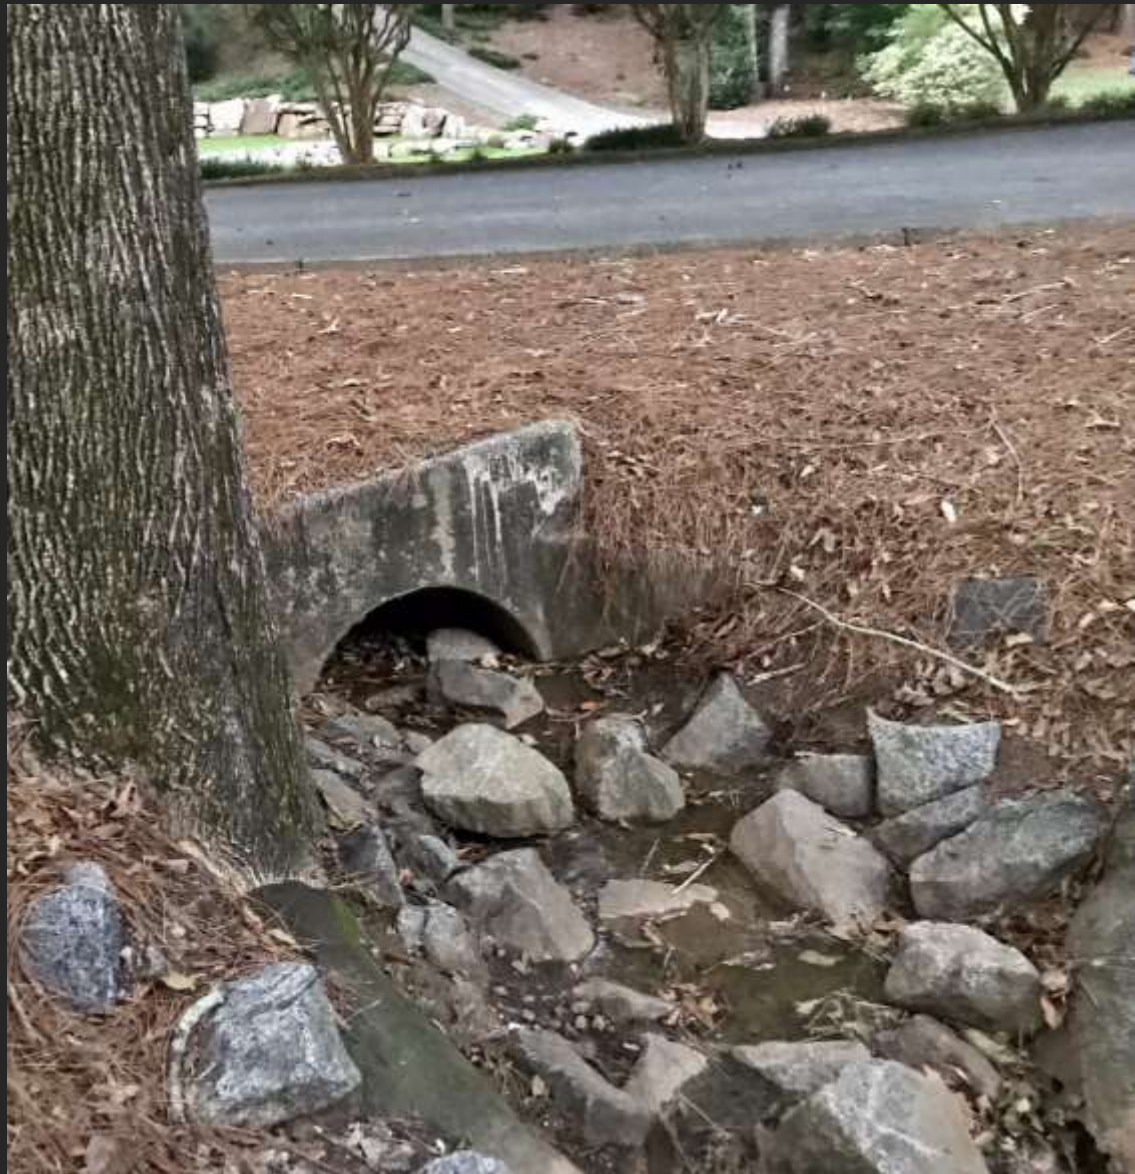
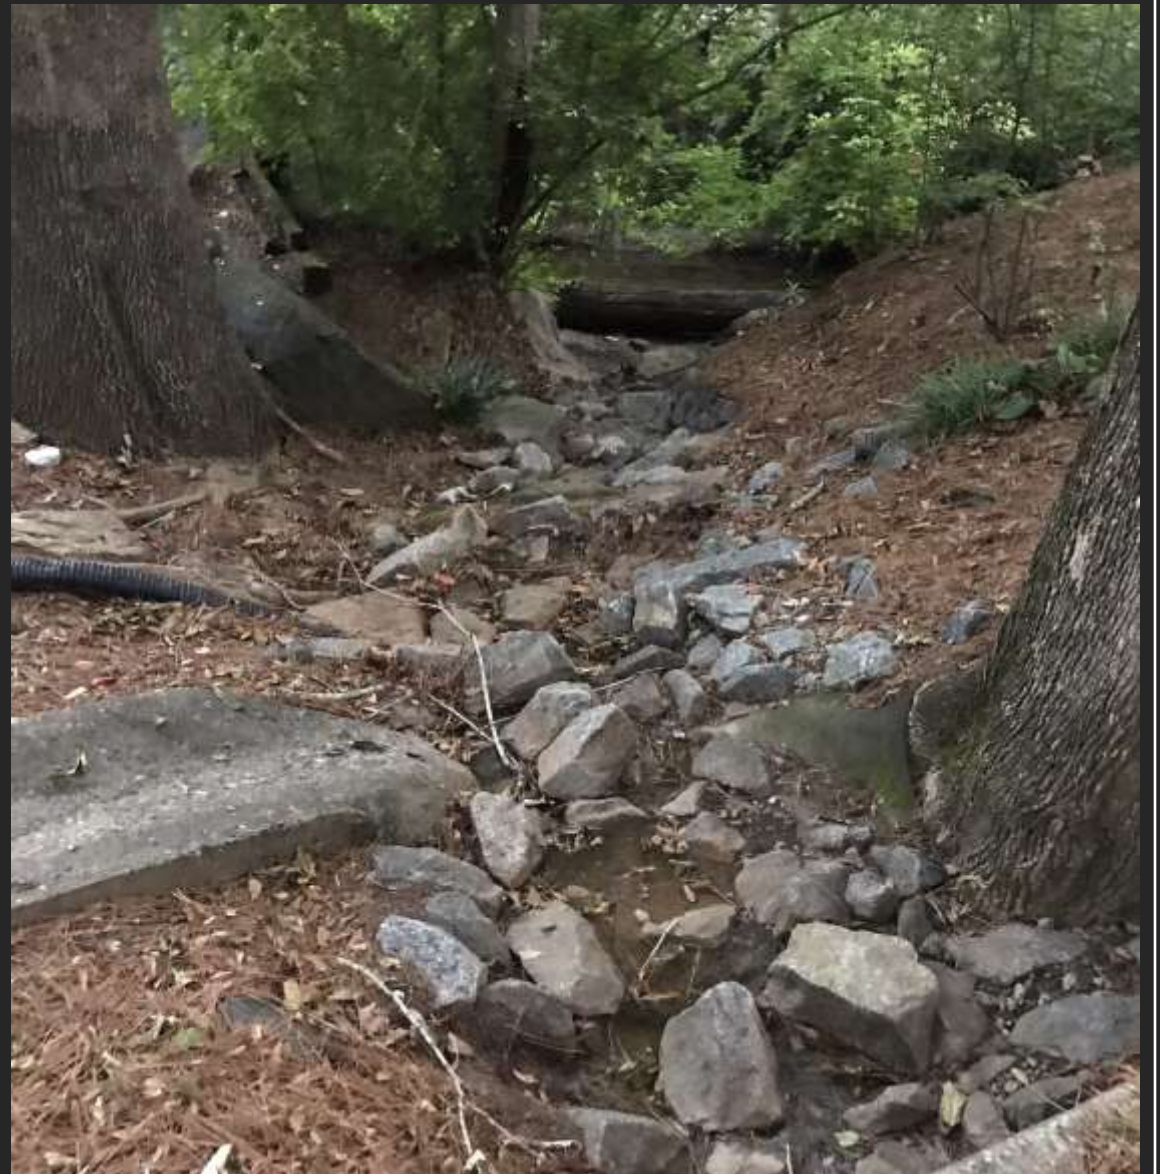
- Loss of streambank and HOA property along pool
- Tidal action during dam release and high storm water flows
- Stormwater flow from parking lot/street drainage
- Double rise of creek due to high storm water and dam release
- Extreme erosion due to loss of vegetation and straightened channel
- HOA BUDGET

-
- Original plan proposed j-hooks and rock weirs to be tied into a 3:1 slope with toe wood placed along the left and right banks.
 - Due to tight location of pool house and width of the stream, this existing condition did not allow for originally proposed 3:1 slopes.
 - The HOA only owned the right bank downstream so full in-stream structures were not practicable.
 - Expense of full instream structures and toe wood not practicable for HOA's budget.

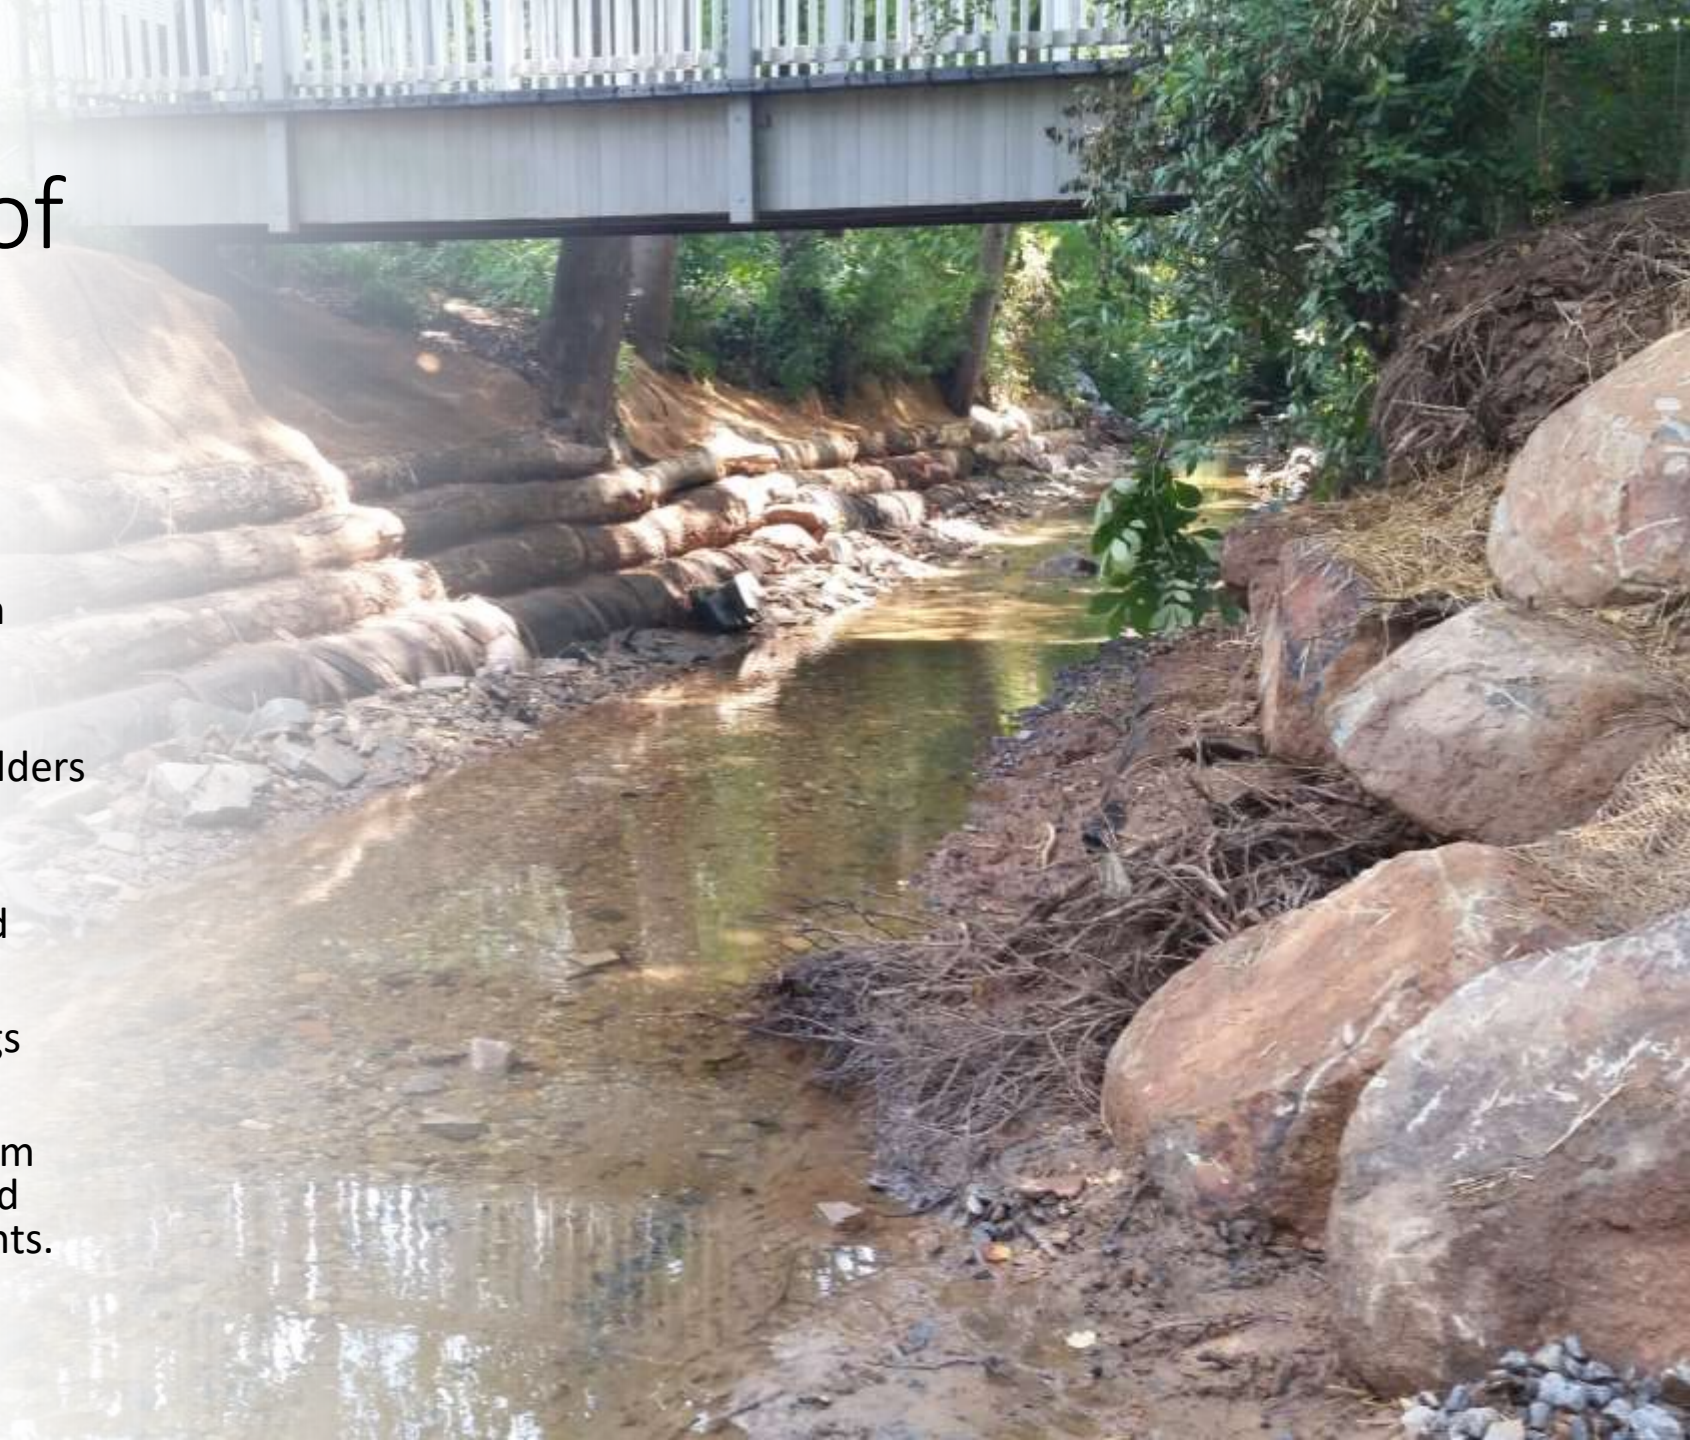
- Improved shading of stream
- Improved interstitial spaces within stream bed due to intermixing of sediment and streambed gravel
- Insertion of root wads and boulders increased fishery habitat
- Reduction of overland flow into stream with large boulder reduced streambank erosion
- HOA budget met with donated logs and boulders
- No loss of trees and minimal stream impact due to small machinery and manual labor during low flow events.
