High Definition Stream Survey Chattahoochee River, GA  
Crayfish Creek Tributary 6/23/2020

# THE HIGH-DEFINITION STREAM SURVEY OF THE CHATTAHOOCHEE RIVER NATIONAL RECREATION AREA, GEORGIA

HIGHLIGHTING A FAST AND FLEXIBLE METHOD TO DOCUMENT STREAM CORRIDOR CONDITIONS LEADING TO RESTORATION ACTIONS

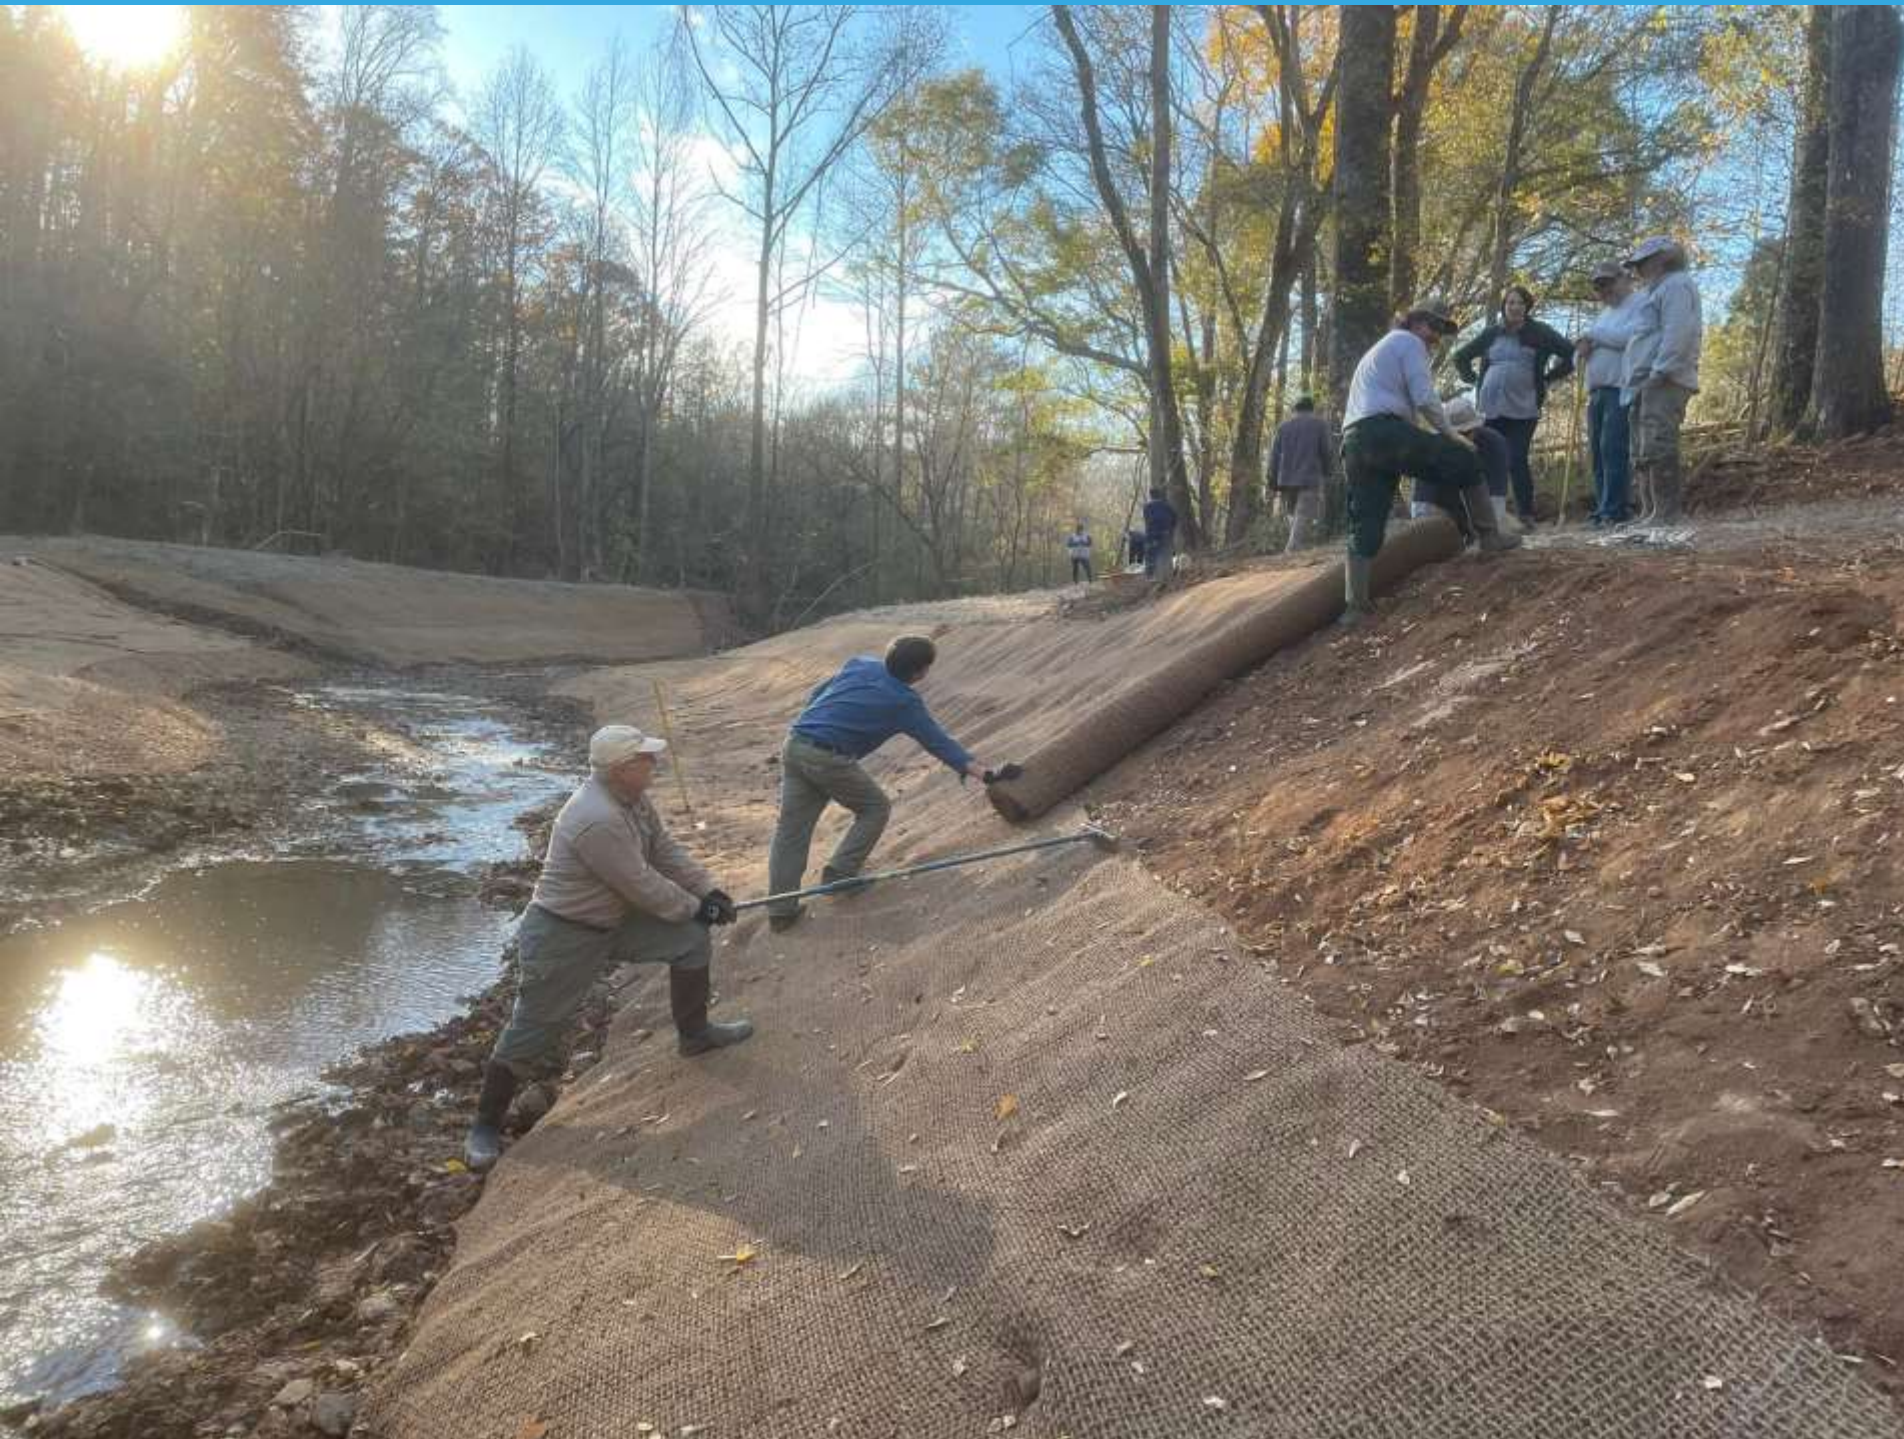
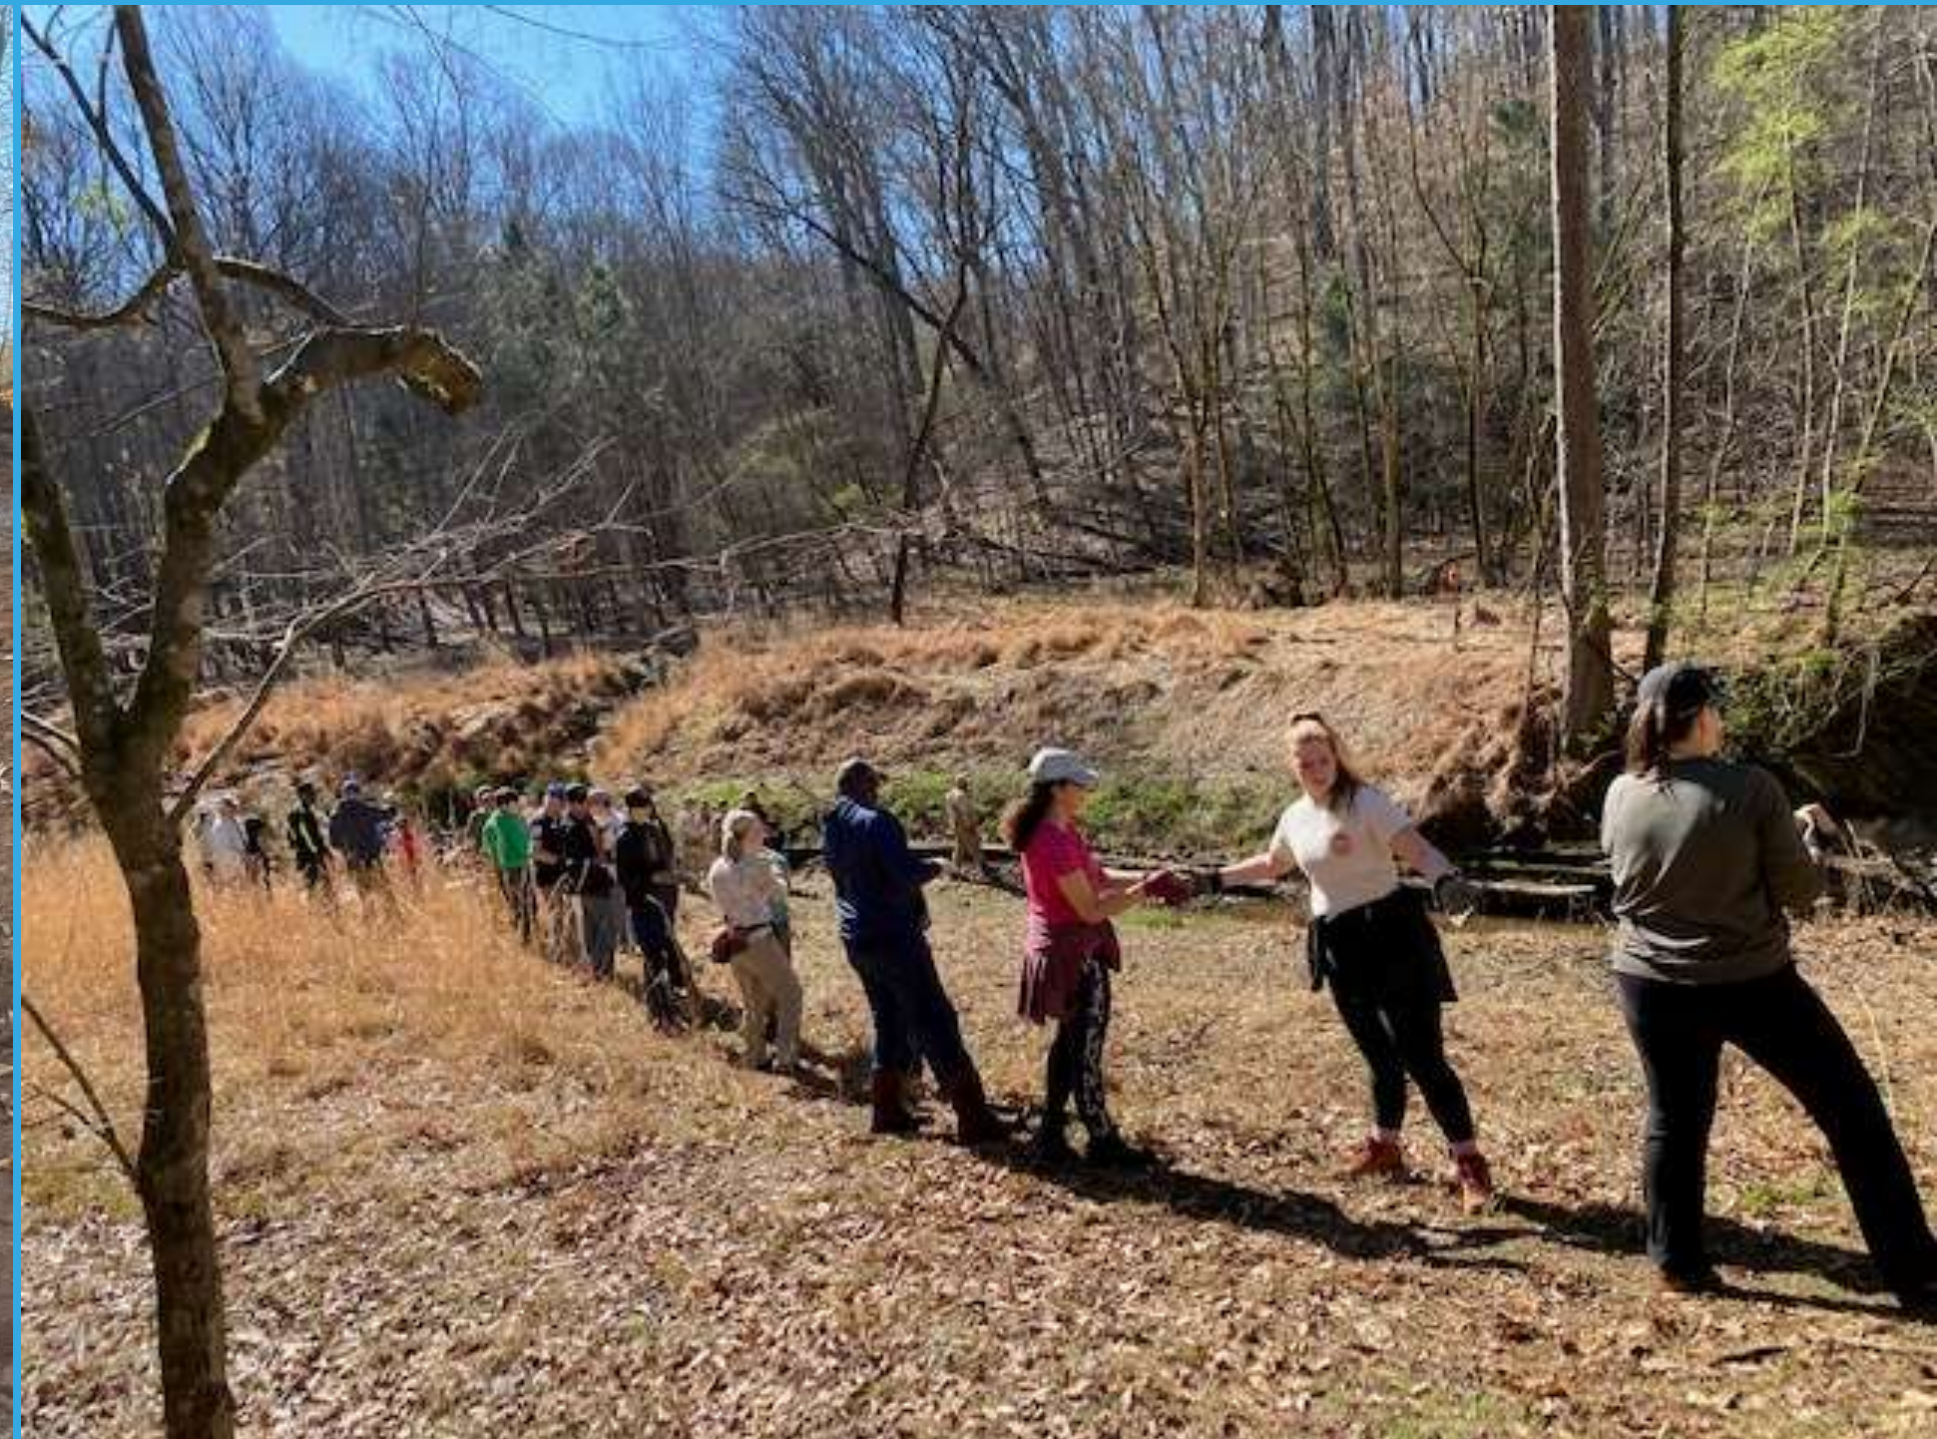
# Crayfish Creek Restoration

**Problem:** The CC1 segment of Crayfish Creek is located in the lower downstream portion of the surveyed stream and had both functional and discrete point features documented. This segment had streambanks actively eroding and collapsing (Figure 52) into the stream. Also, the streambed was over-widened and filled with fine sediment. A debris dam and defunct culverts (Figure 53) exacerbated the overall condition of stream by constricting discharge that increased the erosive forces during high flow events. In addition to the active channel failure and the discrete point features listed above an additional 10 unique point features were also documented along this SOC, consisting of LWD (n=8) and in channel bars (n=2); however, they have minor or negligible impact directly on the stream channel. A small section streambed (approximately 4 m) was classified as modified due to the presence of the deteriorating culverts.

**Problem Cause:** Crayfish Creek overall appeared to suffer from stormwater and sediment runoff related issues. Development in the upper portions of the watershed have led to excessive stormwater and sediment in the lower portions of stream. The increased frequency and magnitude in flow volumes during heavy rainfall events exceed the natural capacity

**Restoration Approach:** This area may require two separate restoration approaches. The first restoration activity would be a channel restoration designed to effectively transport water during high flow events and pass sediment through the system. The specifics of this restoration action are difficult to determine due to the fact that the dominant problems influencing the stream are upstream of the survey area. Emphasis for mitigation efforts directed to stormwater and sediment detention in the upper watershed are warranted.

The second approach would be the removal and disposal of the debris dam and defunct culverts. This would reduce the local constriction created in this area, thus reducing the water force and erosive power. Only accomplishing this second activity in the absence of the first, will likely make natural restoration of this area in the long term unlikely. Final project design would incorporate stormwater flow and sediment detention, channel stabilization as well as grade control measures near its confluence with the Chattahoochee River.
